CONDITION REPORT

Report No:
2017316574
DATE
23/10/2026

Vehicle Type	PASSENGER VEHICLE	Registered Owner	MFC AUCTION HOUSE
Manufacturer	MERCEDES-BENZ	Registration Number	JZT168MP
Model	C180 CGI BLUEEFFICIENCY AT [2010-2011]	Register Number	
VIN	WDD2040492R134608	Date Of First Licensing	
Engine Number		Last COR	
Doors	4	License Expiry Date	31/05/2027
Color	WHITE	Power / Displacement	
Year Model	2010	Paint Finish	TWO COAT UNI
Km Reading	297,609 KM	Fuel	PETROL
Cab / Body Type	SEDAN	Transmission	AUTOMATIC

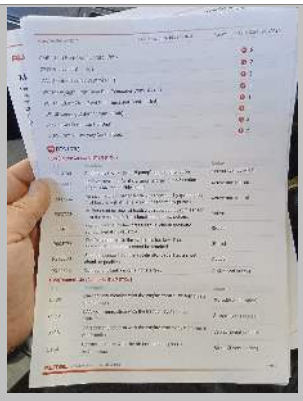
Diagnostic.

No	System	Code	Description	Status
1	ECM	U010900	COMMUNICATION WITH FUEL PUMP HAS A MALFUNCTION

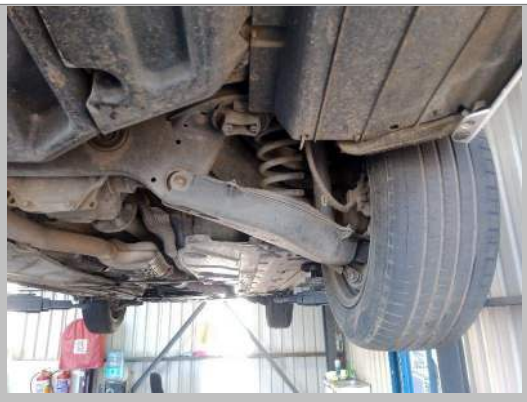
RR TYRE TREAD

Size	Load/Speed Index	Manufacture	Model	Type*	Production Date	Tread Depth (mm)
Front Left	205/55R16	91V	Anchee	Radial	V	0124	2 mm
Front Right	205/55R16	91V	Anchee	Radial	V	0824	2 mm
Rear Left	205/55R16	91V	Autogrip	Radial	V	0225	3 mm
Rear Right	205/55R16	91V	Lanvigator	Radial	V	1822	0 mm

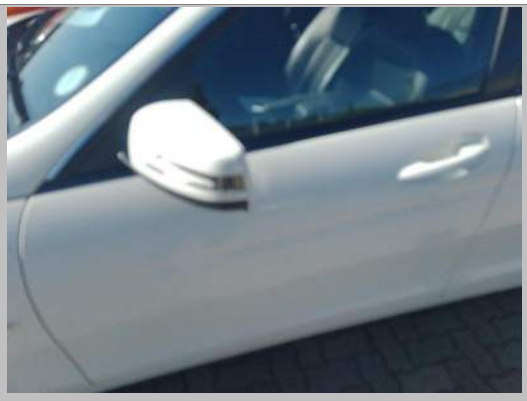
Damage	Repair Way
Engine Oil Leak	Repair
Central Air Vent Damaged	Replace
Engine Management Lights Set	Repair
Air Conditioner Insufficient	Repair
Seat Front Left Damaged	Repair
Seat Front Right Damaged	Repair
Side Mirror Right Damaged	Replace
Front Bumper Damaged	Repair
Grill Damaged	Repair
Bonnet Damaged	Repair
Front Fender Left Damaged	Repair
Front Fender Right Damaged	Repair
Rear Fender Right Damaged	Repair
Door Front Left Damaged	Repair
Door Front Right Damaged	Repair
Door Rear Left Damaged	Repair
Door Rear Right Damaged	Repair
Boot Lid / Hatch door Damaged	Repair
Rear bumper Damaged	Repair
Windscreen Damaged	Replace
Tyre Rear Right Worn	Replace
Gearbox Oil Leak	Replace
Engine Noise Idling / Hunting	Repair
