CONDITION REPORT

Report No:
2017327009
DATE
18/11/2026

Vehicle Type	PASSENGER VEHICLE	Registered Owner	
Manufacturer	MERCEDES-BENZ	Registration Number	FK43BCGP
Model	C220	Register Number	
VIN	WDD2050042R038726	Date Of First Licensing	
Engine Number		Last COR	
Doors	4	License Expiry Date	
Color	GREY	Power / Displacement	
Year Model		Paint Finish	M - METALLIC
Km Reading	285,954 KM	Fuel	DIESEL
Cab / Body Type	SEDAN	Transmission	AUTOMATIC

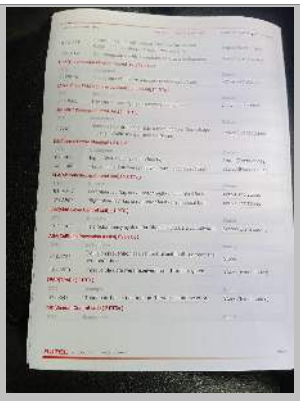
Diagnostic report

No	System	Code	Description	Status
1	ACTIVE AND STORED	B1F4500	THE STARTER BATTERY HAS EXCESSIVE RESISTANCE

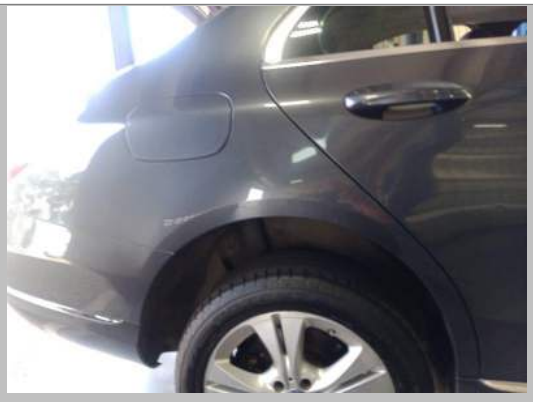
Damage	Repair Way
Engine Oil Leak	Repair
Front Bumper Paintwork • Chipmarks	Repair
Bonnet Paintwork • Chipmarks	Repair
Front Fender Left Paintwork • Chipmarks	Repair
Front Fender Right Paintwork • Scratched	Repair
Rear Fender Left Dented	Repair
Rear Fender Right Dented	Repair
Door Front Left Residual Traces of Repair	Repair
Door Front Right Paintwork • Scratched	Repair
Door Rear Left Dented	Repair
Door Rear Right Dented	Repair
Rear bumper Paintwork • Scratched	Repair
Roof Residual Traces of Repair	Repair
Body exterior	Vehicle got minor scratches, stone chips and dents
No license disc	Replace
Boot not opening	Repair
Body exterior	Signs of spray work done on some body panels
