CONDITION REPORT

Report No:
2017317291
DATE
26/10/2026

Vehicle Type	PASSENGER VEHICLE	Registered Owner	MFC
Manufacturer	FORD	Registration Number	KX96RTGP
Model	ECOSPORT 1.0 TREND [2018-2021]	Register Number	
VIN	WF01XXERK1MM01943	Date Of First Licensing	
Engine Number		Last COR	
Doors	5	License Expiry Date	28/02/2027
Color	WHITE	Power / Displacement	
Year Model	2021	Paint Finish	C - COMMON
Km Reading	104,069 KM	Fuel	PETROL
Cab / Body Type	STATION WAGON	Transmission	MANUAL

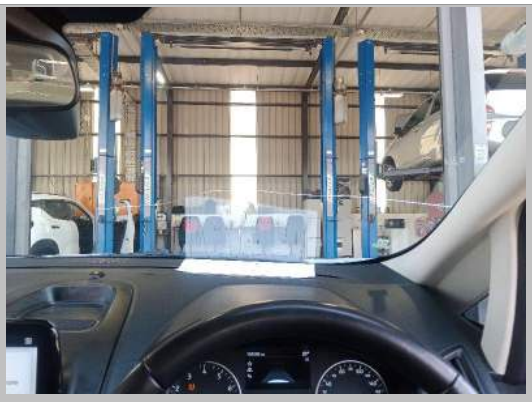
Damage	Repair Way
Front Bumper Paintwork • Scratched	Repair
Bonnet Paintwork • Chipmarks	Repair
Front Fender Left Paintwork • Scratched	Repair
Front Fender Right Paintwork • Chipmarks	Repair
Door Front Left Paintwork • Scratched	Repair
Door Front Right Paintwork • Scratched	Repair
Door Rear Left Dented	Repair
Windscreen Cracked	Replace
