CONDITION REPORT

Report No:
2017305421
DATE
30/09/2026

Vehicle Type	PASSENGER VEHICLE	Registered Owner	MFC
Manufacturer	FORD	Registration Number	LL49CLGP
Model	KUGA 2.0 ECOBOOST ST LINE AWD AT [2018-2021]	Register Number	
		Date Of First Licensing	
VIN	WF0AXXWPMAJA25127	Last COR	
Engine Number		License Expiry Date	31/10/2026
Doors	5	Power / Displacement	
Color	WHITE	Paint Finish	M - METALLIC
Year Model	2019	Fuel	PETROL
Km Reading	128,535 KM	Transmission	AUTOMATIC
Cab / Body Type	STATION WAGON

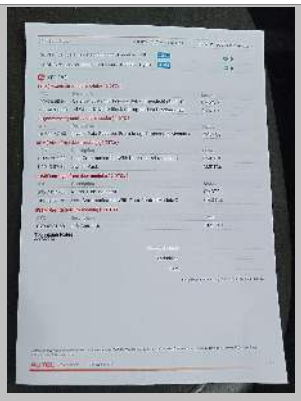
Diagnostic report

No	System	Code	Description	Status
1	CMDTCS	U2013:87-28	SWITCH PACK

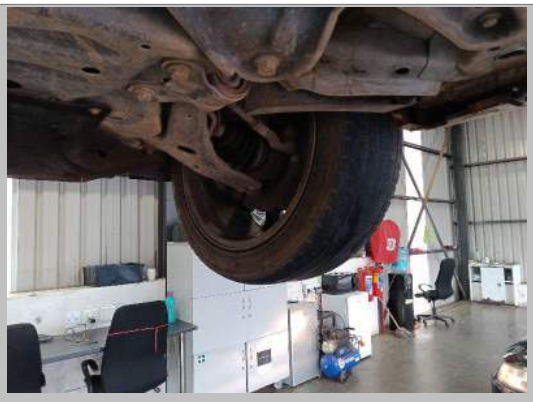
RR TYRE TREAD

Size	Load/Speed Index	Manufacture	Model	Type*	Production Date	Tread Depth (mm)
Front Left	245/45R17	102W	Royal black	Royal explor	V	3124	1 mm
Front Right	245/45R17	102W	Royal black	Royal explor	V	3124	1 mm
Rear Left	245/45R17	102W	Royal black	Royal explor	V	4024	2 mm
Rear Right	245/45R17	102W	Royal black	Royal explor	V	3124	2 mm
Spare	T155/70R17	110M	Maxxis	Temporary	V	3118	4 mm

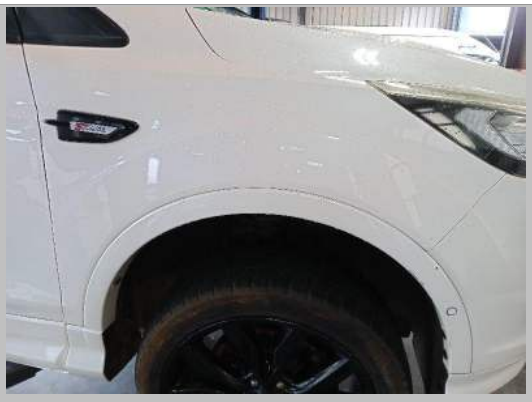
Damage	Repair Way
Front Bumper Paintwork • Chipmarks	Repair
Bonnet Paintwork • Chipmarks	Repair
Front Fender Left Paintwork • Chipmarks	Repair
Front Fender Right Paintwork • Chipmarks	Repair
Door Front Right Paintwork • Chipmarks	Repair
Door Rear Left Paintwork • Chipmarks	Repair
Door Rear Right Paintwork • Chipmarks	Repair
Windscreen Cracked	Replace
Engine light on	Repair
Brakes	No brake test done vehicle is 4wd
