CONDITION REPORT

Report No:
2017311447
DATE
13/10/2026

Vehicle Type	PASSENGER VEHICLE	Registered Owner	MFC
Manufacturer	FORD	Registration Number	FS37DMGP
Model	FIESTA 1.0 ECOBOOST AMBIENTE 5-DR POWERSHIFT [2015-2018]	Register Number	
		Date Of First Licensing	
VIN	WF0DXXGAKDGT63354	Last COR	
Engine Number		License Expiry Date	28/02/2027
Doors	5	Power / Displacement	
Color	WHITE	Paint Finish	TWO COAT UNI
Year Model	2017	Fuel	PETROL
Km Reading	200,171 KM	Transmission	AUTOMATIC
Cab / Body Type	HATCHBACK

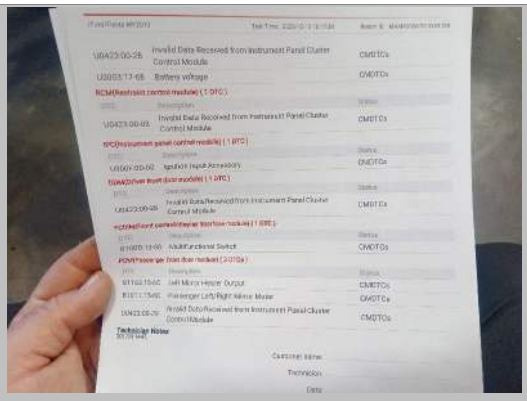
Diagnostic report

During the diagnostic no active error messages were detected. (See also attached Diagnostic Report. For more information regarding the Fault Codes (DTC) and the recommended rectifications please contact the workshops of the vehicle manufacture).

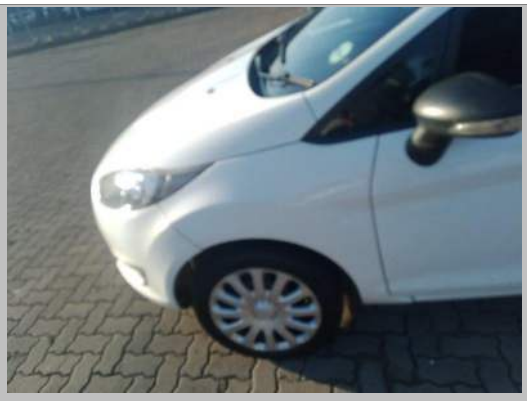
Damage	Repair Way
Engine Oil Leak	Repair
Fan Belt Damaged	Replace
Steering Wheel Trim Worn	Repair
Front Bumper Damaged	Repair
Bonnet Damaged	Repair
Front Fender Left Damaged	Repair
Front Fender Right Damaged	Repair
Rear Fender Left Damaged	Repair
Rear Fender Right Damaged	Repair
Door Front Left Damaged	Repair
Door Front Right Damaged	Repair
Door Rear Left Damaged	Repair
Door Rear Right Damaged	Repair
Boot Lid / Hatch door Damaged	Repair
Rear bumper Damaged	Repair
