CONDITION REPORT

Report No:
2017324195
DATE
11/11/2026

Vehicle Type	PASSENGER VEHICLE	Registered Owner	MFC AUCTION HOUSE
Manufacturer	MINI	Registration Number	JT95KXGP
Model	COOPER S CLUBMAN 2.0 5-DR STEPTRONIC [2019-2024]	Register Number	
		Date Of First Licensing	
VIN	WMWLV720502N88967	Last COR	
Engine Number		License Expiry Date	31/03/2027
Doors	5	Power / Displacement	
Color	SILVER	Paint Finish	M - METALLIC
Year Model	2020	Fuel	PETROL
Km Reading	191,430 KM	Transmission	AUTOMATIC
Cab / Body Type	HATCHBACK

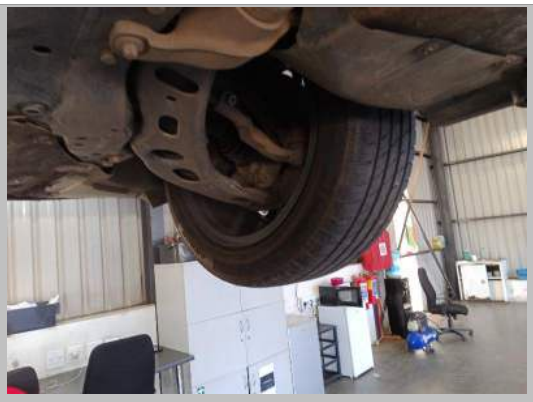
LF TYRE TREAD

Size	Load/Speed Index	Manufacture	Model	Type*	Production Date	Tread Depth (mm)
Front Left	225/45R17	94W	Durun	L919	V	0125	0 mm
Front Right	225/50R17	98W	Annaite	An608	V	2723	3 mm
Rear Left	225/45R17	94W	Durun	L919	V	2325	3 mm
Rear Right	225/45R17	94Y	Windforce	Catchfors	V	3025	3 mm

Damage	Repair Way
Seat Front Right Damaged	Repair
Side Mirror Right Paintwork • Scratched	Repair
Front Bumper Paintwork • Scratched	Repair
Bonnet Residual Traces of Repair	Repair
Door Front Left Dented	Repair
Door Front Right Dented	Repair
Door Rear Left Dented	Repair
Rear bumper Paintwork • Scratched	Repair
Windscreen Cracked	Replace
Tyre Front Left Damaged	Replace
Bolt(s) / Nut(s) Front Wheel Left Missing	Replace
Bolt(s) / Nut(s) Front Wheel Right Missing	Replace
Bolt(s) / Nut(s) Rear Wheel Left Missing	Replace
Bolt(s) / Nut(s) Rear Wheel Right Missing	Replace
Belly plates Damaged	Replace
Traction control light on	Repair
Steering wheel is hard to turn	Repair
Warning light on	Repair
Front tyres size differs	Replace
