CONDITION REPORT

Report No:
2017315344
DATE
22/10/2026

Vehicle Type	PASSENGER VEHICLE	Registered Owner	MFC AUCTION HOUSE
Manufacturer	PORSCHE	Registration Number	CW05PCGP
Model	CAYENNE E2 S 4.8 V8 4X4 8-SP TIPTRONIC [2010-2014]	Register Number	
		Date Of First Licensing	
VIN	WP1ZZZ92ZELA56725	Last COR	
Engine Number		License Expiry Date	
Doors	5	Power / Displacement	
Color	WHITE	Paint Finish	TWO COAT UNI
Year Model	2013	Fuel	PETROL
Km Reading	154,831 KM	Transmission	AUTOMATIC
Cab / Body Type	SUV

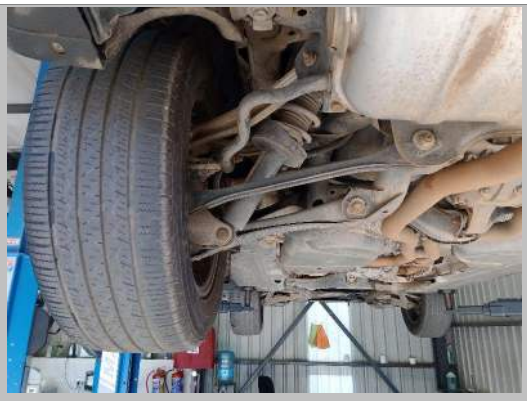
General Comments: ACCORDING TO THE AGE AND MILEAGE OF THE VEHICLE, NORMAL WEAR AND TEAR MARKS ARE VISIBLE ON THE INTERIOR, EXTERIOR, ELECTRICAL AND MECHANICAL PARTS. 32 DTC'S AT TIME OF TESTING SEE DTC REPORT.Electrical Components and Instruments: vehicle electronics malfunctioning. automatic opening hatchdoor malfunctioning. hatchdoor does not open or close properly.
Body • Exterior: Minor dents and scratches and stone chips to body panels. Signs of repair work done to body panels. Poor alignment to somebody panels.
Tyres and Rims: Spare wheel missing.
Undercarriage: signs of surfaced rust on undercarriage of vehicle.

Undercarriage front.

Undercarriage rear.

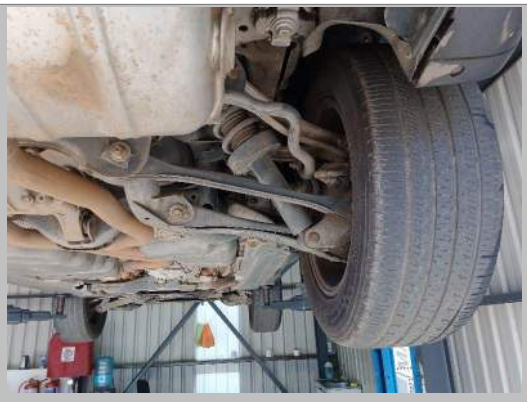
Size	Load/Speed Index	Manufacture	Model	Type*	Production Date	Tread Depth (mm)
Front Left	255/55R18	109V	Michelin	Radial	V	1116	0 mm
Front Right	255/55R18	109W	Hilo	Radial	V	4620	0 mm
Rear Left	255/55R18	109W	Hilo	Radial	V	4620	2 mm
Rear Right	255/55R18	109W	Hilo	Radial	V	4620	0 mm

LF TYRE TREAD

LR TYRE TREAD

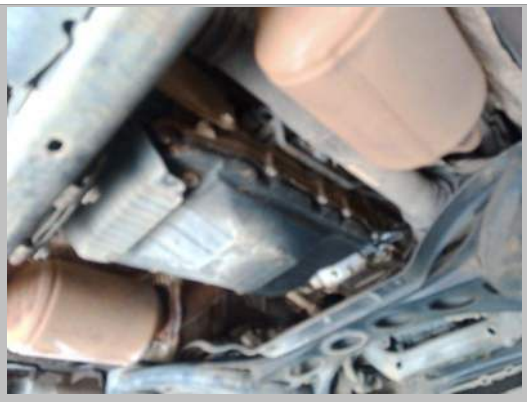
Damage	Repair Way
Engine Oil Leak	Repair
Engine Management Lights Set	Repair
Switch Electrical Window Winder front left Defective	Repair
Switch Electrical Window Winder front right Defective	Repair
Front Bumper Damaged	Repair
Bonnet Damaged	Repair
Front Fender Left Dented	Repair
Front Fender Right Damaged	Repair
Rear Fender Left Damaged	Repair
Door Front Left Damaged	Repair
Door Front Right Damaged	Repair
Door Rear Left Damaged	Repair
Door Rear Right Damaged	Repair
Boot Lid / Hatch door Damaged	Repair
Rear bumper Damaged	Repair
Steering box Leak	Replace
Tyre Front Left Worn	Replace
Tyre Front Right Worn	Replace
Tyre Rear Right Worn	Replace
Spare Tyre Defective	Replace
Bolt(s) / Nut(s) Rear Wheel Left Missing	Replace
Belly plates Damaged	Replace
Gearbox Oil Leak	Repair
4x4 Differential Lock Malfunction	Repair
