CONDITION REPORT

Report No:
2017316738
DATE
23/10/2026

Vehicle Type	PASSENGER VEHICLE	Registered Owner	
Manufacturer	VOLKSWAGEN	Registration Number	HM99RPGP
Model	KOMBI T6 SWB 2.0 TDI TRENDLINE MPV DSL 75KW [2016-2018]	Register Number	
		Date Of First Licensing	
VIN	WV2ZZZ7HZHH098875	Last COR	
Engine Number		License Expiry Date	30/11/2025
Doors	5	Power / Displacement	
Color	WHITE	Paint Finish	TWO COAT UNI
Year Model	2017	Fuel	DIESEL
Km Reading	384,440 KM	Transmission	MANUAL
Cab / Body Type	STATION WAGON

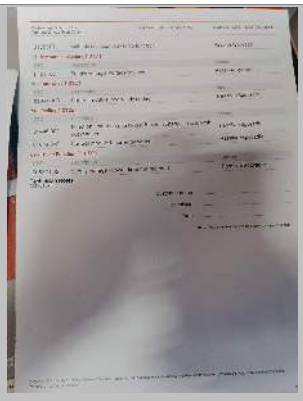
Diagnostic.

No	System	Code	Description	Status
1	ENGINE CONTROL MODEL 1	P023600	TURBOCHARGER ROOST SENSOR CIRCUIT RANGE PERFORMANCE

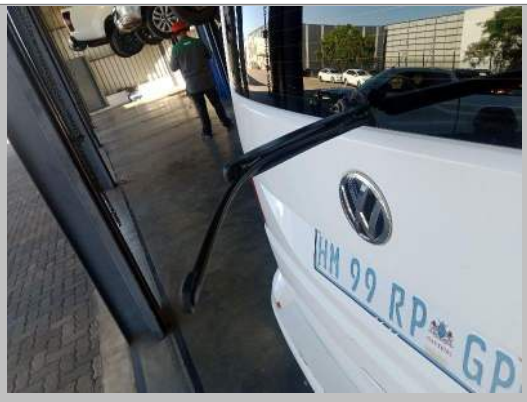
Damage	Repair Way
Engine Oil Leak	Repair
Central Air Vent Damaged	Replace
Engine Management Lights Set	Repair
Switch Electrical Window Winder front left Damaged	Replace
Switch Electrical Window Winder front right Damaged	Replace
Windscreen Wiper Damaged	Replace
Tail Light Left Damaged	Replace
Headlight Left Damaged	Replace
Headlight Right Damaged	Replace
Seat Front Left Damaged	Repair
Seat Front Right Damaged	Repair
Seat Rear Damaged	Repair
Seat Rear (2. Row) Damaged	Repair
Side Mirror Left Damaged	Replace
Side Mirror Right Damaged	Replace
Front Bumper Damaged	Repair
Grill Damaged	Repair
Bonnet Damaged	Repair
Front Fender Left Damaged	Repair
Front Fender Right Damaged	Repair
Rear Fender Left Damaged	Repair
Rear Fender Right Damaged	Repair
Door Front Left Damaged	Repair
Door Front Right Damaged	Repair
Door Rear Left Damaged	Repair
Door Rear Right Damaged	Repair
Boot Lid / Hatch door Damaged	Repair
Rear bumper Damaged	Repair

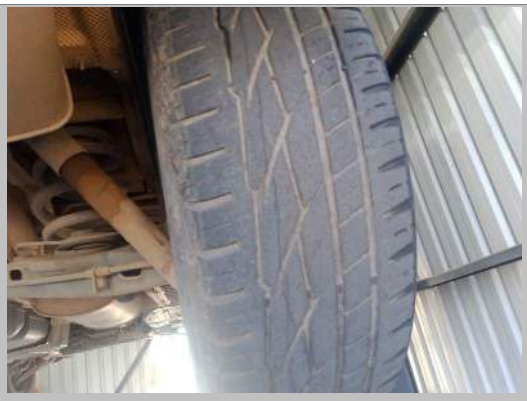
Roof Damaged	Repair
Windscreen Damaged	Replace
Shock Absorber Rear Right Worn	Replace
Control Arm Bush(es) Front Axle Left Worn	Replace
Control Arm Bush(es) Front Axle Right Worn	Replace
Tyre Front Left Worn	Replace
Tyre Front Right Worn	Replace
Tyre Rear Left Worn	Replace
Tyre Rear Right Worn	Repair
Spare Tyre Damaged	Replace
Engine mountings Damaged	Replace
Excessive noise from front and rear suspension.	Repair
Rear tyres size differs	Replace

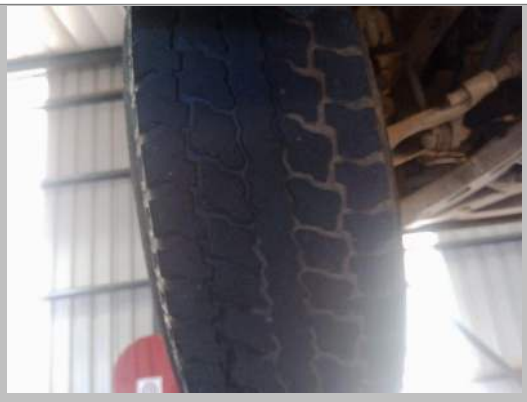
Tyre Rear Right

Size	Load/Speed Index	Manufacture	Model	Type*	Production Date	Tread Depth (mm)
Front Left	205R16C	108S	Continental	Worldcontac	V	3220	0 mm
Front Right	205R16C	108S	Continental	Worldcontac	V	0324	0 mm
Rear Left	215/70R16	106T	Goodyear	Marathon	V	0424	0 mm
Rear Right	215/65R16	98H	General	Radial	V	3816	0 mm
Spare	195/75R16	108R	Dunlop	Sp	V	1022	1 mm
