CONDITION REPORT

Report No:
2017316480
DATE
23/10/2026

Vehicle Type	PASSENGER VEHICLE	Registered Owner	
Manufacturer	VOLKSWAGEN	Registration Number	KR13RNGP
Model	TIGUAN 2.0 TDI TREND&FUN BLUEMOTION DSL [2011-2015]	Register Number	
		Date Of First Licensing	
VIN	WVGZZZ5NZEW009649	Last COR	
Engine Number		License Expiry Date	31/08/2026
Doors	5	Power / Displacement	
Color	SILVER	Paint Finish	M - METALLIC
Year Model	2013	Fuel	DIESEL
Km Reading	298,019 KM	Transmission	MANUAL
Cab / Body Type	HATCHBACK

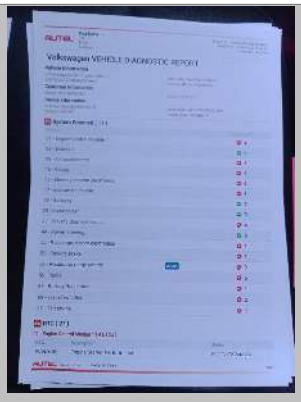
Diagnostic Report page 1

No	System	Code	Description	Status
1	PASSIVE SPORADIC	P06E900	ENGINE STARTER PERFORMANCE

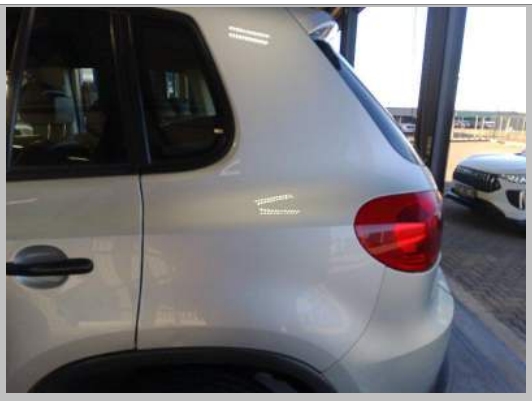
Damage	Repair Way
Central Locking Malfunction	Repair
Tail Light Left Cracked	Replace
Side Mirror Right Damaged	Repair
Front Bumper Paintwork • Scratched	Repair
Bonnet Paintwork • Chipmarks	Repair
A • Pillar Right Paintwork • Chipmarks	Repair
Front Fender Left Residual Traces of Repair	Repair
Front Fender Right Residual Traces of Repair	Repair
Rear Fender Left Paintwork • Scratched	Repair
Rear Fender Right Paintwork • Scratched	Repair
Door Front Left Residual Traces of Repair	Repair
Door Front Right Paintwork • Scratched	Repair
Door Rear Left Paintwork • Scratched	Repair
Door Rear Right Paintwork • Scratched	Repair
Boot Lid / Hatch door Dented	Repair
Rear bumper Paintwork • Scratched	Repair
Engine to silencer pipe Welded	Repair
After market Air filter fitted	Repair
Boot not opening can not see spare wheel	Repair
Engine management lights illuminated	Repair
Both front fender liner damage	Repair
