CONDITION REPORT

Report No:
2017316731
DATE
23/10/2026

Vehicle Type	PASSENGER VEHICLE	Registered Owner	
Manufacturer	VOLKSWAGEN	Registration Number	KR48KLGP
Model	POLO SEDAN 1.4 TRENDLINE [2020-2022]	Register Number	
VIN	WVWZZZ60ZMT119482	Date Of First Licensing	
Engine Number		Last COR	
Doors	4	License Expiry Date	30/06/2027
Color	WHITE	Power / Displacement	
Year Model	2021	Paint Finish	TWO COAT UNI
Km Reading	365,265 KM	Fuel	PETROL
Cab / Body Type	SEDAN	Transmission	MANUAL

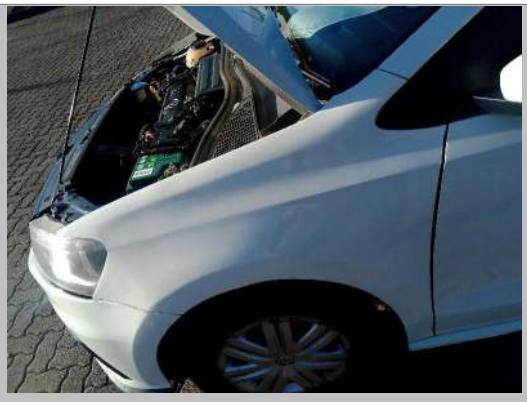
Damage	Repair Way
Central Air Vent Damaged	Repair
Radio/CD/USB Defective	Repair
Headlight Left Damaged	Replace
Headlight Right Damaged	Replace
Seat Front Right Damaged	Repair
Front Bumper Damaged	Repair
Bonnet Damaged	Repair
C • Pillar Right Damaged	Repair
Front Fender Left Damaged	Replace
Front Fender Right Damaged	Repair
Rear Fender Left Damaged	Repair
Rear Fender Right Damaged	Repair
Door Front Left Damaged	Repair
Door Front Right Damaged	Repair
Door Rear Left Damaged	Repair
Door Rear Right Damaged	Repair
Boot Lid / Hatch door Damaged	Repair
Rear bumper Damaged	Repair
Roof Damaged	Repair
Tyre Front Left Worn	Replace
Tyre Rear Left Worn	Replace
Tyre Rear Right Worn	Replace
Radiator Cradle Damaged	Replace

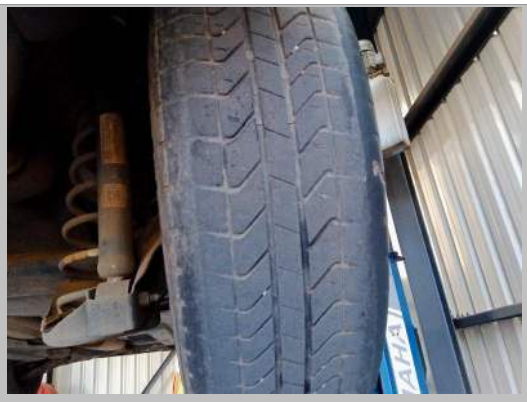
Tyre Rear Left

Size	Load/Speed Index	Manufacture	Model	Type*	Production Date	Tread Depth (mm)
Front Left	175/70R14	93S	Sumitomo	Radial	V	00000	0 mm
Front Right	175/70R14	84H	Sumitomo	Radial	V	4523	2 mm
Rear Left	175/70R14	84T	Anchee	Radial	V	2125	0 mm
Rear Right	175/70R14	84H	Sumitomo	Radial	V	2224	0 mm
