CONDITION REPORT

Report No:
2017311222
DATE
13/10/2026

Vehicle Type	PASSENGER VEHICLE	Registered Owner	
Manufacturer	VOLKSWAGEN	Registration Number	JR15JWGP
Model	GOLF 7 2.0 TSI GTI 5-DR DSG [2017-2019]	Register Number	
VIN	WVWZZZAUZHW332609	Date Of First Licensing	
Engine Number		Last COR	
Doors	5	License Expiry Date	31/10/2024
Color	WHITE	Power / Displacement	
Year Model	2018	Paint Finish	C - COMMON
Km Reading	93,591 KM	Fuel	PETROL
Cab / Body Type	HATCHBACK	Transmission	AUTOMATIC

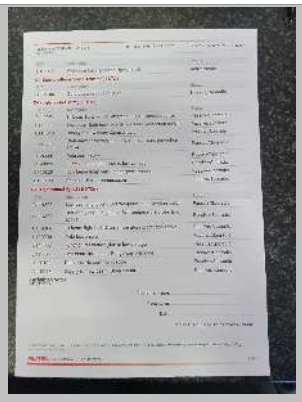
Diagnostic Report page 1

No	System	Code	Description	Status
1	ACTIVE STATIC	B122D29	LOCKING UNIT FOR CENTRAL LOCKING, RANGE PERFORMANC
