CONDITION REPORT

Report No:
2017313846
DATE
19/10/2026

Vehicle Type	PASSENGER VEHICLE	Registered Owner	
Manufacturer	VOLKSWAGEN	Registration Number	JD92NDGP
Model	GOLF 7 2.0 TSI GTI 5-DR DSG [2019-2021]	Register Number	
VIN	WVWZZZAUZKW103130	Date Of First Licensing	
Engine Number		Last COR	
Doors	5	License Expiry Date	
Color	WHITE	Power / Displacement	
Year Model	2019	Paint Finish	TWO COAT UNI
Km Reading	206,898 KM	Fuel	PETROL
Cab / Body Type	HATCHBACK	Transmission	AUTOMATIC

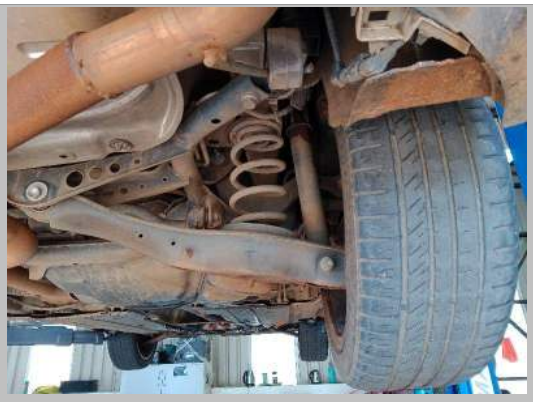
RF TYRE TREAD

Size	Load/Speed Index	Manufacture	Model	Type*	Production Date	Tread Depth (mm)
Front Left	225/40Z R18	92Y	Sumitomo	HTR	V	2022	1 mm
Front Right	225/40Z R18	92Y	Sumitomo	HTR	V	3323	1 mm
Rear Left	225/40Z R18	92Y	Sumitomo	HTR	V	3323	1 mm
Rear Right	225/40Z R18	92W	Saffiro	SF5000	V	1018	0 mm
Spare	T125/70 R18	99M	Linglong	Temporary	V	4218	2 mm

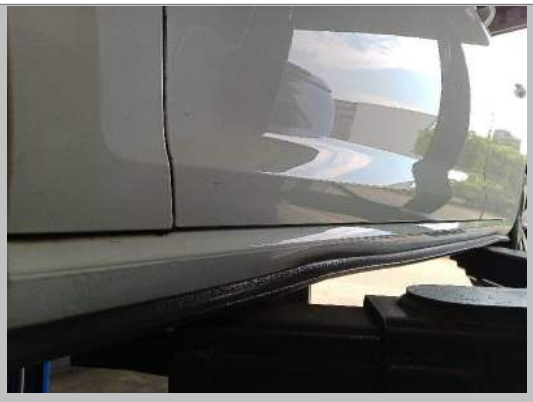
Damage	Repair Way
Engine Oil Leak	Repair
Engine Wiring Defective	Repair
Caps Missing	Replace
Hoses Oil Leak	Replace
Fan Belt Damaged	Replace
Bonnet stay and shocks Damaged	Replace
Under bonnet insulation cover Damaged	Replace
Fog Light Front Right Damaged	Replace
Seat Front Right Damaged	Repair
Seat Belt Front Right Damaged	Replace
Parcel Tray Damaged	Repair
Front Bumper Damaged	Repair
Bonnet Paintwork • Chipmarks	Repair
C • Pillar Right Residual Traces of Repair	Repair
Front Fender Right Residual Traces of Repair	Repair
Rear Fender Left Residual Traces of Repair	Repair
Rear Fender Right Residual Traces of Repair	Repair
Door Front Left Paintwork • Scratched	Repair
Door Front Right Residual Traces of Repair	Repair
Door Rear Left Residual Traces of Repair	Repair
Door Rear Right Paintwork • Scratched	Repair
Boot Lid / Hatch door Residual Traces of Repair	Repair
Rear bumper Residual Traces of Repair	Repair
Sill Panel Left Damaged	Repair
