CONDITION REPORT

Report No:
2017316062
DATE
22/10/2026

Vehicle Type	PASSENGER VEHICLE	Registered Owner	MFC AUCTION HOUSE
Manufacturer	VOLKSWAGEN	Registration Number	MK20RJGP
Model	POLO SEDAN 1.6 MPI 81KW [2023-ON]	Register Number	
VIN	WVWZZZD2ZRT015215	Date Of First Licensing	
Engine Number		Last COR	
Doors	4	License Expiry Date	30/04/2027
Color	SILVER	Power / Displacement	
Year Model	2023	Paint Finish	C - COMMON
Km Reading	125,475 KM	Fuel	PETROL
Cab / Body Type	SEDAN	Transmission	MANUAL

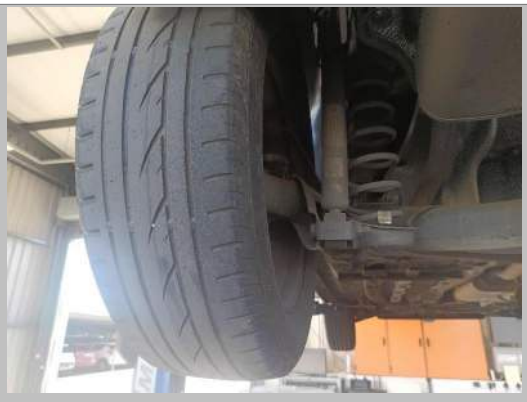
LF TYRE TREAD

Size	Load/Speed Index	Manufacture	Model	Type*	Production Date	Tread Depth (mm)
Front Left	205/55R16	91V	ROYAL BLACK	Royal Mile	V	4625	4 mm
Front Right	205/55R16	91V	ROYAL BLACK	Royal Mile	V	4425	4 mm
Rear Left	205/55R16	91V	CONTINENTAL	premium cont	V	4223	4 mm
Rear Right	205/55R16	91V	CONTINENTAL	contipremium	V	0524	4 mm
Spare	195/65R15	91H	MRF	ECOTRED	V	////	5 mm
