MFC Auction House  
M57 Pretoria Rd, Glenmarais, KEMPTON PARK  
Gauteng

DEKRA MFC  
M57 Pretoria Rd - 1619  
KEMPTON PARK - GT  
08610 33572

## Assignment

| Manufacturer | VOLKSWAGEN | Registration Number | KTH593NW |

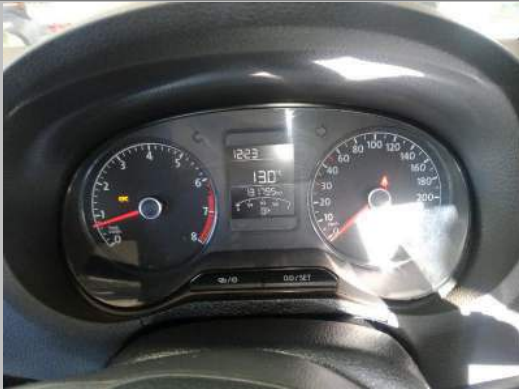
DASHBOARD (W/ ENGINE RUNNING)

| Damage | Repair Way |
|---|---|
| EPC light on | Repair |

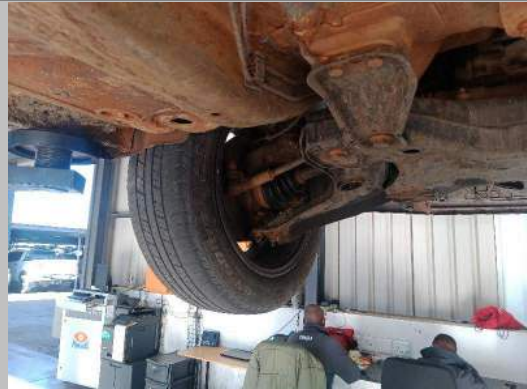
LF TYRE TREAD

| Damage | Repair Way |
|---|---|
| Front tyres size differs | Replace |

| | Size | Load/Speed Index | Manufacture | Model | Type* | Production Date | Tread Depth (mm) |
|---|---|---|---|---|---|---|---|
| Front Left | 185/60R15 | 84H | Rapid | Eco809 | V | 4122 | 3 mm |

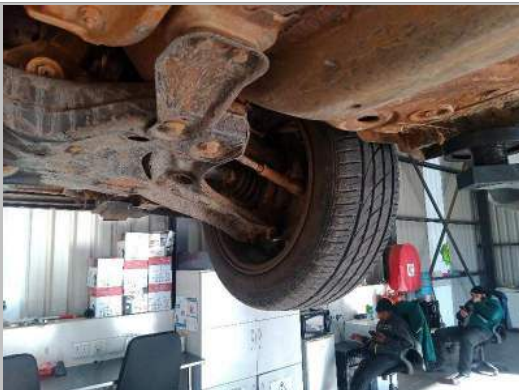
RF TYRE TREAD

| | Size | Load/Speed Index | Manufacture | Model | Type* | Production Date | Tread Depth (mm) |
|---|---|---|---|---|---|---|---|
| Front Right | 195/50R15 | 82V | Velocity | Speed max | V | 1919 | 4 mm |

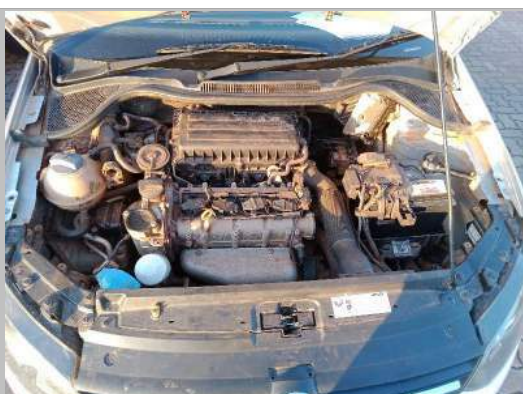
ENGINE 1

| Damage | Repair Way |
|---|---|
| Engine Oil Sweat | Repair |
