## CONDITION REPORT

Report No: 2016850234

| Manufacturer | VOLKSWAGEN | Registration Number | JRC363MP |
| Model | POLO VIVO 1.4 55KW TRENDLINE 5-DR [2018-2020] | Register Number | |

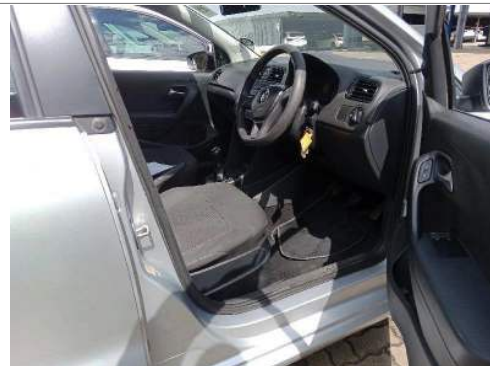
INTERIOR (FRONT DRIVER DOOR)

| Damage | Repair Way |
|---|---|
| Switch Electrical Window Winder front right Defective | Repair |

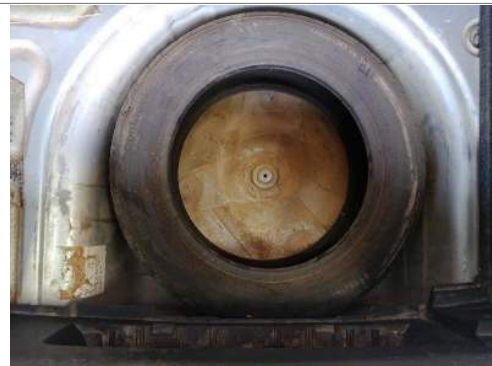
tyre no rim
