## CONDITION REPORT

Report No:  
2017304590  
DATE  
29/09/2026

| Manufacturer | VOLKSWAGEN | Registration Number | HLF524L |
| Model | POLO VIVO 1.6 77KW HIGHLINE 5-DR [2018-2020] | Register Number | |

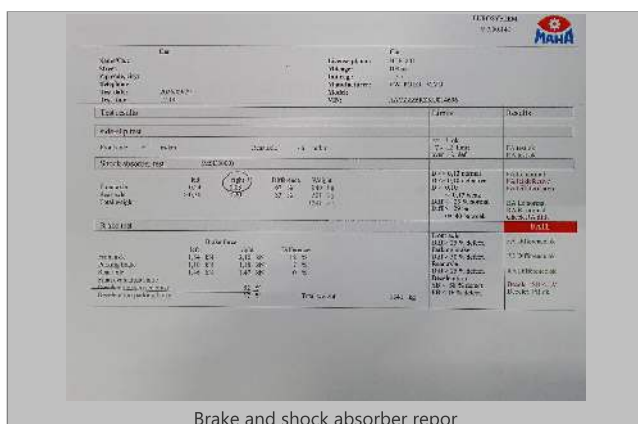
Brake and shock absorber report

| Front right shock absorber weak | Replace |
| Deceleration service brake defective | Repair |

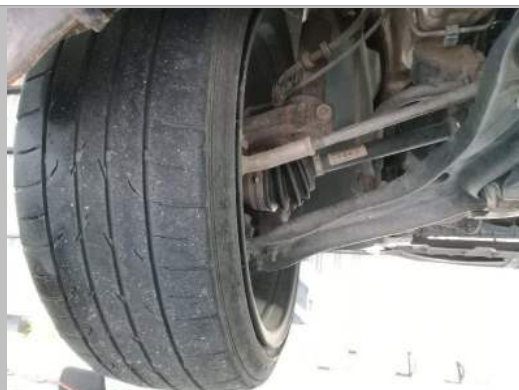
LF TYRE TREAD

| | Size | Load/Speed Index | Manufacture | Model | Type* | Production Date | Tread Depth (mm) |
|---|---|---|---|---|---|---|---|
| Front Left | 205/40 R17 | 84H | Dunlop | Direzza | V | 2821 | 1 mm |

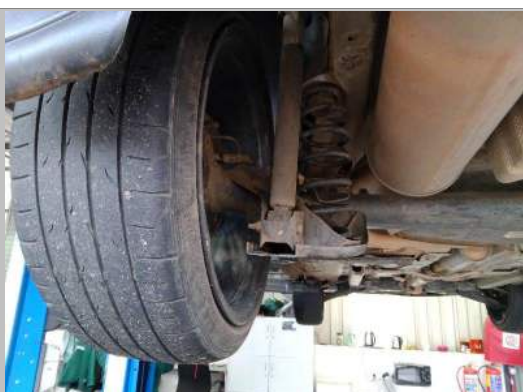
LR TYRE TREAD

| Rim Rear Left Welded | Replace |

| | Size | Load/Speed Index | Manufacture | Model | Type* | Production Date | Tread Depth (mm) |
|---|---|---|---|---|---|---|---|
| Rear Left | 205/40 R17 | 84W | Dunlop | Direzza | V | 4721 | 1 mm |

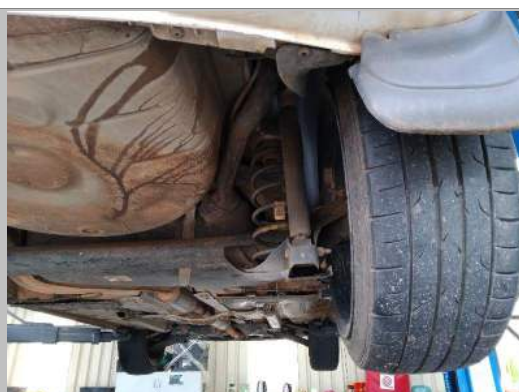
RR TYRE TREAD

| Tyre Rear Right Damaged | Replace |
| Rim Rear Right Scratched | Repair |

| | Size | Load/Speed Index | Manufacture | Model | Type* | Production Date | Tread Depth (mm) |
|---|---|---|---|---|---|---|---|
| Rear Right | 205/40 R17 | 84W | Dunlop | Direzza | V | 2821 | 2 mm |

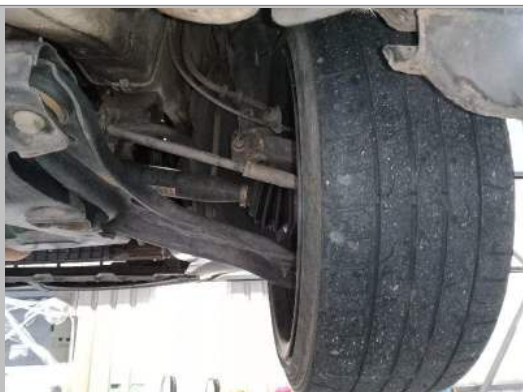
RF TYRE TREAD

| Tyre Front Right Damaged | Replace |

| | Size | Load/Speed Index | Manufacture | Model | Type* | Production Date | Tread Depth (mm) |
|---|---|---|---|---|---|---|---|
| Front Right | 205/40 R17 | 84W | Dunlop | Direzza | V | 4721 | 0 mm |
