CONDITION REPORT

Report No: 2016255640

DATE
05/02/2024

Vehicle Type	PASSENGER VEHICLE	Registered Owner	MFC AUCTION HOUSE
Manufacturer	VOLKSWAGEN	Registration Number	FMG705L
Model	POLO VIVO	Register Number	
VIN	AAVZZZ6RZMU001395	Date Of First Licensing	
Engine Number		Last COR	
Doors	5	License Expiry Date	31/07/2024
Color	WHITE	Power / Displacement	
Year Model		Paint Finish	TWO COAT UNI
Km Reading	102,879 KM	Fuel	PETROL
Cab / Body Type	HATCHBACK	Transmission	MANUAL

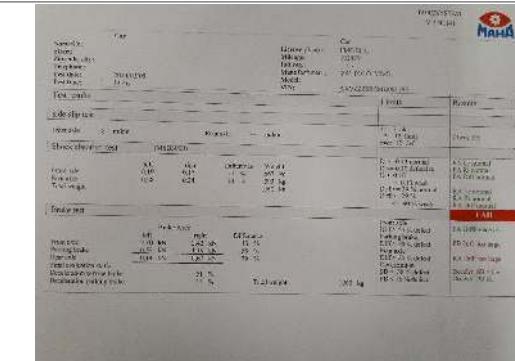
Brake and shock absorber report

Left	Right	Axle Weight [KG]	Deceleration [m/s ²]
	Braking Force [kN]	Braking Force [kN]		
Front	2.1	2.42	-	
Rear	0.14	0.67	-	
Emergency / Parking	0.53	1.19	-

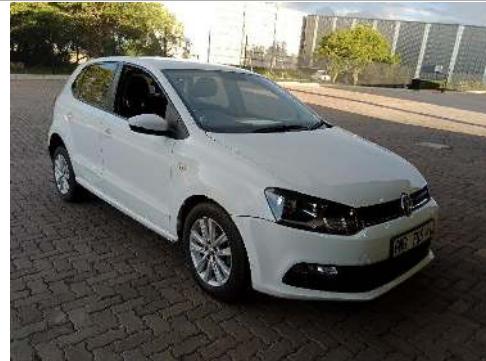
FRONT RIGHT CORNER

Damage	Repair Way
Engine Oil Sweat	Repair
Headlight Right Scratched	Repair
Seat Front Left Dirty	Repair
Seat Front Right Damaged	Repair
Seat Rear Dirty	Repair
Interior Mirror Loose / Excessive Play	Replace
Hood Lining Defective	Repair
Door Handle Rear Right Defective	Repair
Door Sealing Rubber Front Right Damaged	Replace
Parcel Tray Damaged	Replace
Steering Wheel Trim Defective	Repair
Number Plate Rear Dented	Repair
Front Bumper Damaged	Repair
Bonnet Paintwork • Chipmarks	Repair
Front Fender Left Paintwork • Scratched	Repair
Front Fender Right Dented	Repair
Rear Fender Left Paintwork • Scratched	Repair
Rear Fender Right Damaged	Repair
Door Front Left Damaged	Repair
Door Front Right Dented	Repair
Door Rear Left Damaged	Repair
Door Rear Right Damaged	Repair
Boot Lid / Hatch door Paintwork • Scratched	Repair
Rear bumper Paintwork • Scratched	Repair
Inner Boot Floor Pan and Spare Wheel Well Paintwork • Scratched	Repair

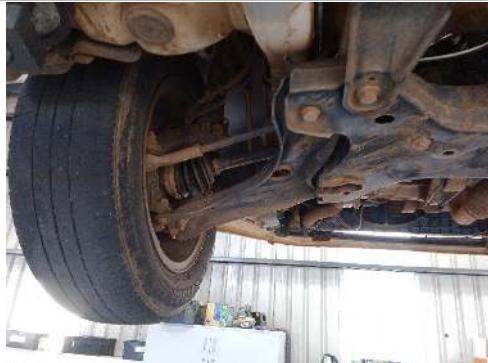
LF TYRE TREAD

Size	Load/Speed Index	Manufacture	Model	Type*	Production Date	Tread Depth (mm)
Front Left	185/65 R15	88H	Bridgestone	B250	V	3419	1 mm
Front Right	185/65 R15	88H	Bridgestone	B250	V	3319	2 mm
Rear Left	185/65 R15	88H	Bridgestone	B250	V	3419	0 mm
Rear Right	185/60 R15	88H	Firestone	Touring	V	4222	0 mm
