MFC Auction House  
M57 Pretoria Rd, Glenmarais, KEMPTON PARK  
Gauteng

## Assignment

| Manufacturer | VOLKSWAGEN | Registration Number | KTC357NW |
| Model | POLO VIVO | Register Number | |

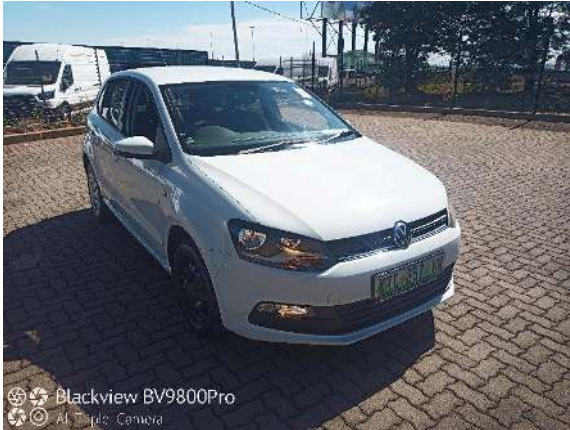
FRONT RIGHT CORNER

| Damage | Repair Way |
|---|---|
| Sill Panel Right Dented | Repair |

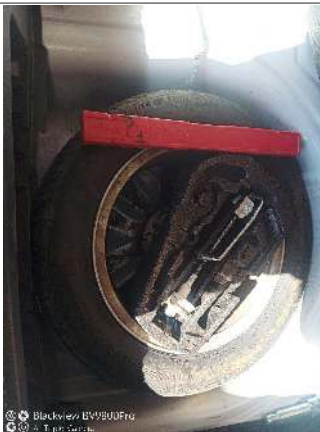
| | Size | Load/Speed Index | Manufacture | Model | Type* | Production Date | Tread Depth (mm) |
|---|---|---|---|---|---|---|---|
| Spare | 195/60R15 | 88V | Firestone | Touring | V | 2618 | 3 mm |

Spare wheel fitted

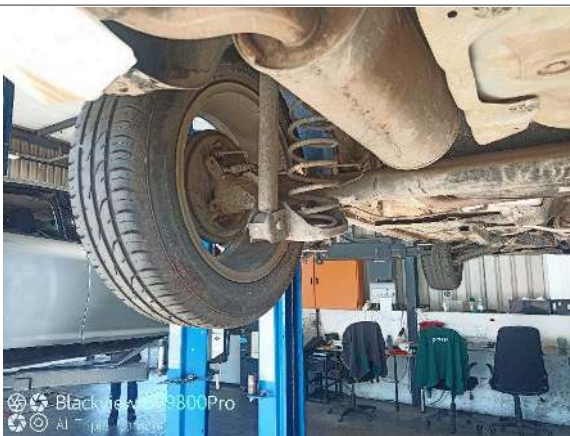
LR TYRE TREAD

| | Size | Load/Speed Index | Manufacture | Model | Type* | Production Date | Tread Depth (mm) |
|---|---|---|---|---|---|---|---|
| Rear Left | 185/60R15 | 84H | Continental | Contact | V | 2622 | 3 mm |

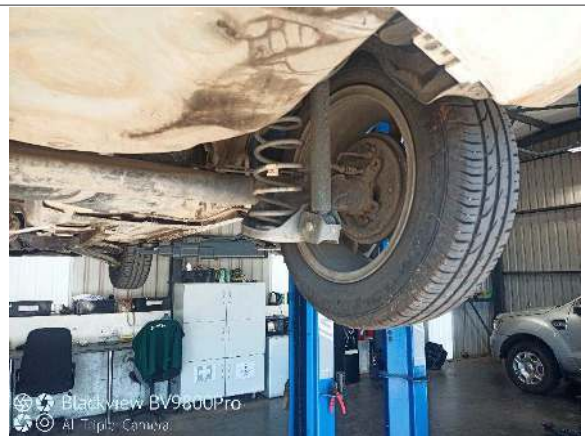
RR TYRE TREAD

| | Size | Load/Speed Index | Manufacture | Model | Type* | Production Date | Tread Depth (mm) |
|---|---|---|---|---|---|---|---|
| Rear Right | 185/60R15 | 84H | Continental | Contact | V | 2622 | 3 mm |
