CONDITION REPORT

Report No: 2016842116

MFC Auction House  
M57 Pretoria Rd, Glenmarais, KEMPTON PARK  
Gauteng

Vehicle Type	PASSENGER VEHICLE	Registered Owner	
Manufacturer	VOLKSWAGEN	Registration Number	KX33LXGP
Model	POLO VIVO 1.4 63KW COMFORTLINE 5-DR [2022-2024]	Register Number	
VIN	AAVZZZ6RZPU002991	Date Of First Licensing	
Engine Number		Last COR	
Doors	5	License Expiry Date	30/11/2025
Color	WHITE	Power / Displacement	
Year Model	2022	Paint Finish	C - COMMON
Km Reading	76,488 KM	Fuel	PETROL
Cab / Body Type	HATCHBACK	Transmission	MANUAL

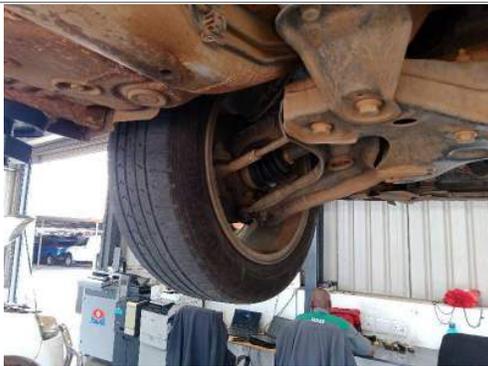
LF TYRE TREAD

Size	Load/Speed Index	Manufacture	Model	Type*	Production Date	Tread Depth (mm)
Front Left	195/55R16	91V	Continental	Contact	V	0322	3 mm
Front Right	195/55R16	91V	Continental	Contact	V	3822	3 mm
Rear Left	195/55R16	87V	Hilo	Genesys	V	4020	0 mm
Rear Right	195/55R16	91V	Continental	Contact	V	3722	3 mm
Spare	175/70R14	84T	Firestone	Touring	V	0000	2 mm

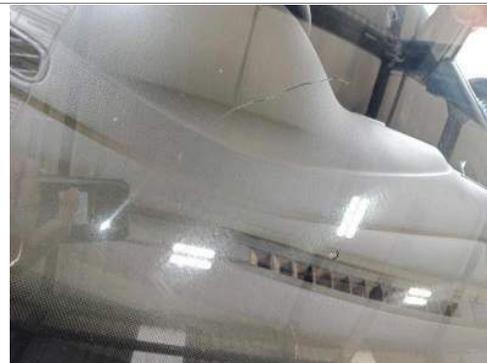
Damage	Repair Way
Tail Light Left Damaged	Replace
Dim Light Left Malfunction	Repair
Fog Light Front Right Malfunction	Repair
Front Bumper Paintwork • Scratched	Repair
Bonnet Paintwork • Pitmarks	Repair
Front Fender Right Dented	Repair
Rear Fender Left Paintwork • Scratched	Repair
Rear Fender Right Dented	Repair
Door Front Left Paintwork • Scratched	Repair
Door Front Right Paintwork • Scratched	Repair
Door Rear Left Paintwork • Scratched	Repair
Door Rear Right Paintwork • Scratched	Repair
Rear bumper Paintwork • Scratched	Repair
Roof Paintwork • Pitmarks	Repair
Windscreen Cracked	Repair
Parking Brake Performance Left / Right Difference out of legal range	Repair
Tyre Rear Left Smooth	Repair
Windscreen washers not working	Repair

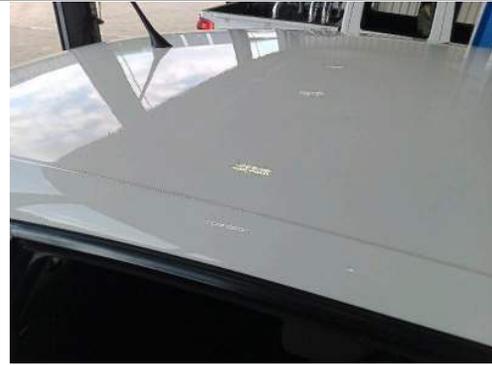
Roof

General Comments: ACCORDING TO THE AGE AND MILEAGE OF THE VEHICLE, NORMAL WEAR AND TEAR MARKS ARE VISIBLE ON THE INTERIOR, EXTERIOR, ELECTRICAL AND MECHANICAL PARTS. Body • Exterior: Vehicle got minor scratches, stone chips and dents. Signs of spray work done on some body panels.
