CONDITION REPORT

Report No:  
2016961522  
DATE  
29/07/2025

| Manufacturer | VOLKSWAGEN | Registration Number | HBD705L |
| Model | POLO VIVO 1.4 63KW COMFORTLINE 5-DR [2022-2024] | Register Number | |

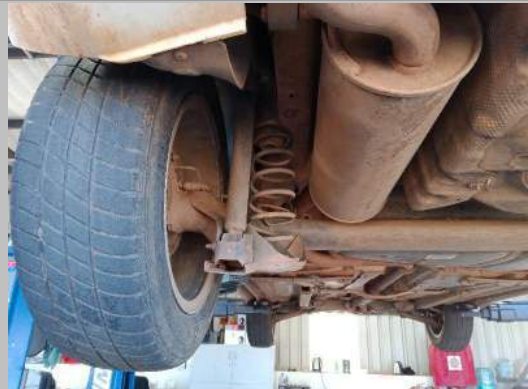
LR TYRE TREAD

| Damage | Repair Way |
|---|---|
| Tyre Rear Left Damaged | Replace |

| | Size | Load/Speed Index | Manufacture | Model | Type* | Production Date | Tread Depth (mm) |
|---|---|---|---|---|---|---|---|
| Rear Left | 185/65 R15 | 92T | Barum | Brillantis | V | 0714 | 0 mm |

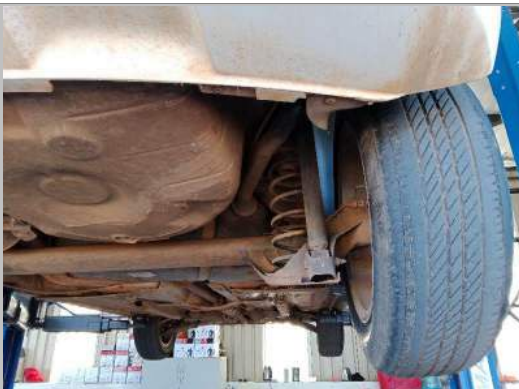
RR TYRE TREAD

| Damage | Repair Way |
|---|---|
| Tyre Rear Right Damaged | Replace |

| | Size | Load/Speed Index | Manufacture | Model | Type* | Production Date | Tread Depth (mm) |
|---|---|---|---|---|---|---|---|
| Rear Right | 185/65 R15 | 88H | Rapid | Eco809 | V | 3121 | 0 mm |

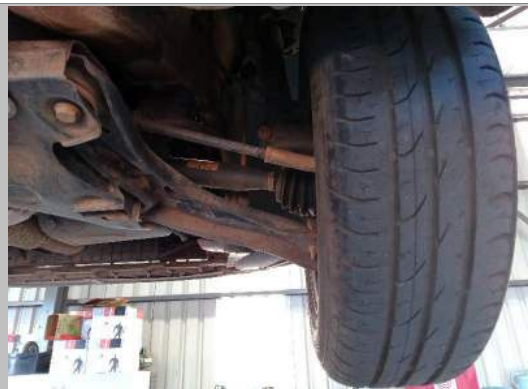
RF TYRE TREAD

| | Size | Load/Speed Index | Manufacture | Model | Type* | Production Date | Tread Depth (mm) |
|---|---|---|---|---|---|---|---|
| Front Right | 185/60 R15 | 84H | Continental | Contipremuim | V | 1923 | 2 mm |
