## CONDITION REPORT

Report No:  
2017302479  
DATE  
23/09/2026

| Manufacturer | VOLKSWAGEN | Registration Number | HR50VXGP |
| Model | POLO 1.0 TSI 70KW TRENDLINE 5-DR [2018-2020] | Register Number | |

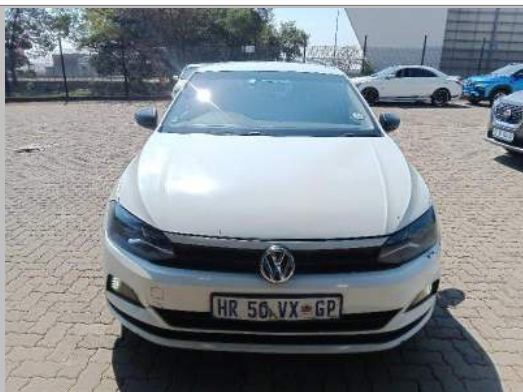
90 DEGREE FRONT

Body • Exterior: Poor residual traces of repair on body panels.Body panels misaligned.Stone chips and spray work on body panels.Dents and scratches on body panels.Signs of impact damage to front of vehicle.

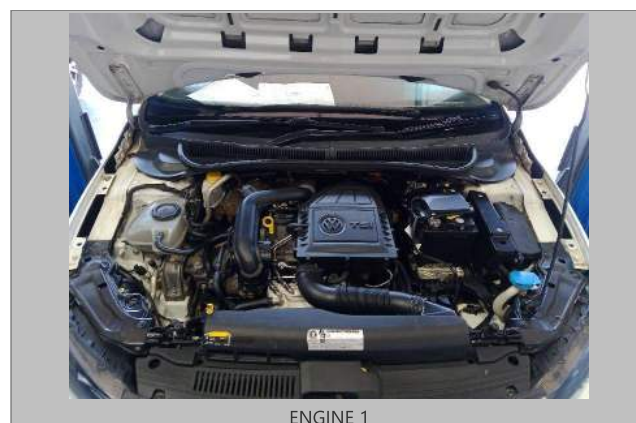
ENGINE 1

General Comments: ACCORDING TO THE AGE AND MILEAGE OF THE VEHICLE, NORMAL WEAR AND TEAR MARKS ARE VISIBLE ON THE INTERIOR, EXTERIOR, ELECTRICAL AND MECHANICAL PARTS.Engine Compartment: Signs of oil leak on turbo.

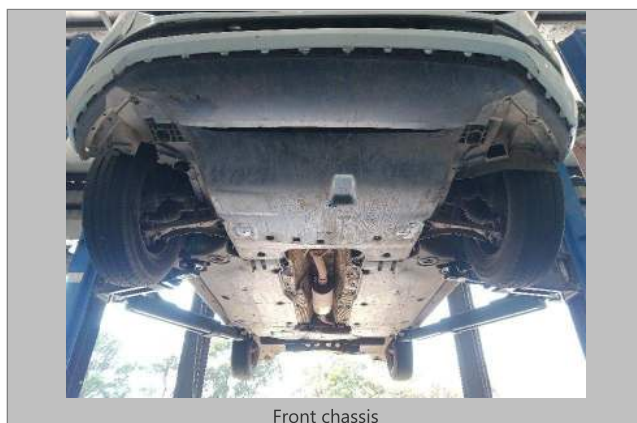
Front chassis

Undercarriage: Signs of water leak on bottom of engine.Bottom of engine and gearbox fully covered.Cannot pin direction of water leak.

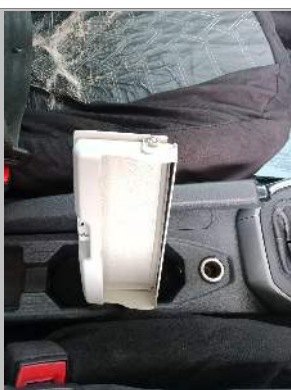
| Damage | Repair Way |
|---|---|
| Center Console / Cubbyhole + Lid Damaged | Repair |
