## CONDITION REPORT

Report No:  
2017305036  
DATE  
30/09/2026

MFC Auction House  
M57 Pretoria Rd, Glenmarais, KEMPTON PARK  
Gauteng

| Manufacturer | VOLKSWAGEN | Registration Number | KB38RTGP |

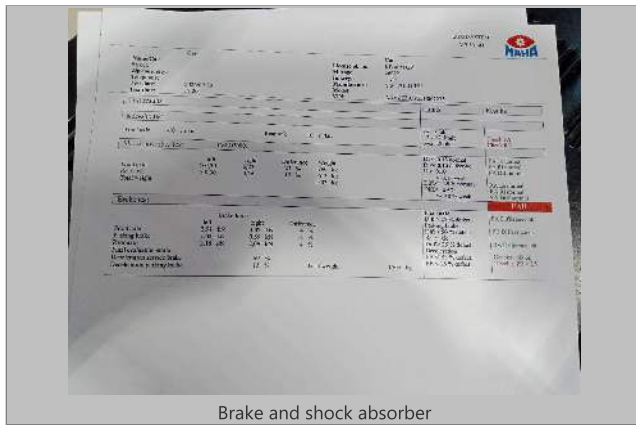
Brake and shock absorber

| | Left | Right | | |
|---|---|---|---|---|
| Front | 2.91 | 3.02 | - | |
| Rear | 2.18 | 2.09 | - | |
| Emergency / Parking | 1.02 | 0.89 | - | |

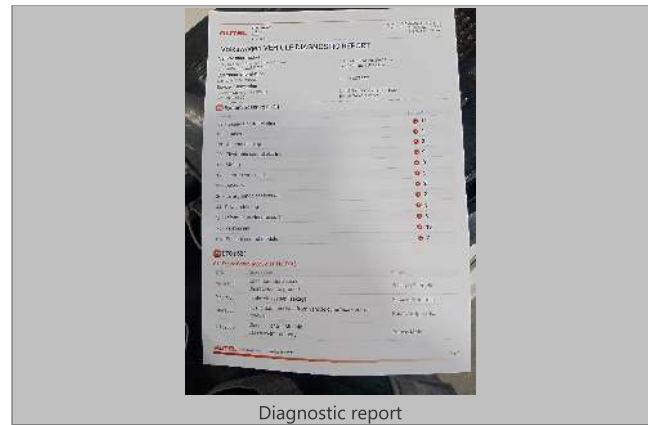
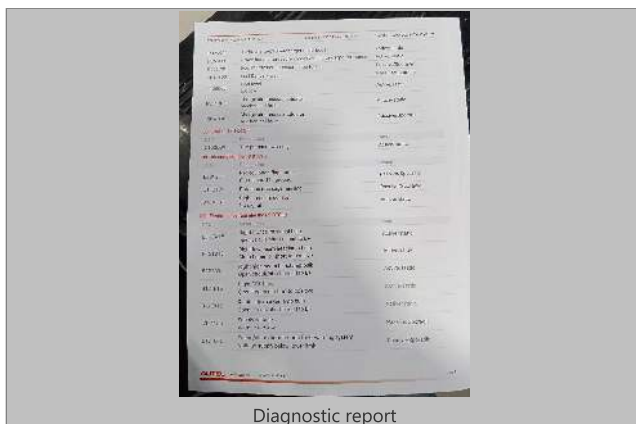
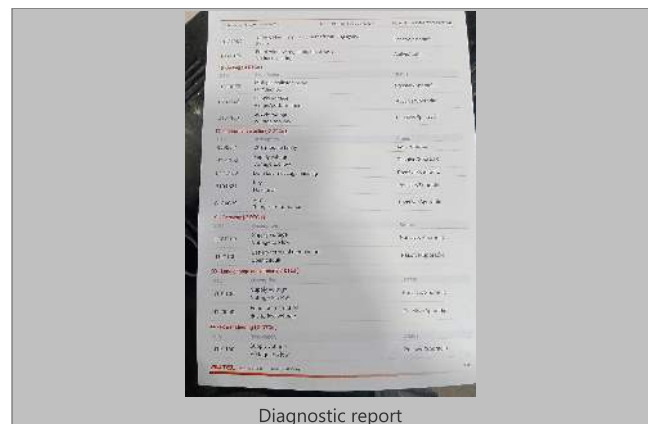
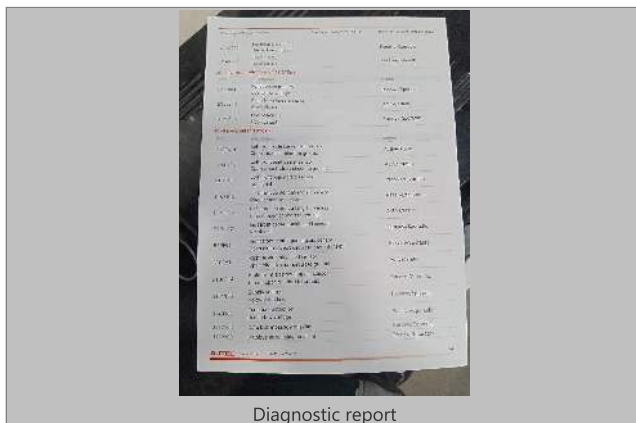
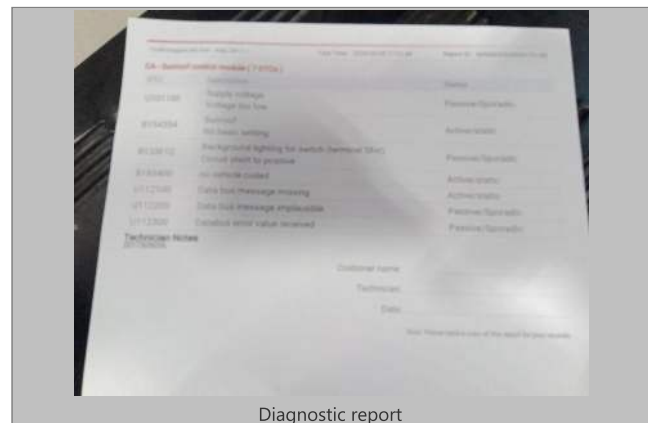
Diagnostic report

During the diagnostic the following error messages were detected: (See also attached Diagnostic Report. For more information regarding the Fault Codes (DTC) and the recommended rectifications please contact the workshops of the vehicle manufacture).

General Comments: ACCORDING TO THE AGE AND MILEAGE OF THE VEHICLE, NORMAL WEAR AND TEAR MARKS ARE VISIBLE ON THE INTERIOR, EXTERIOR, ELECTRICAL AND MECHANICAL PARTS. 62 DTC'S AT TIME OF TESTING SEE DTC REPORT. VEHICLE MIGHT BE A POSSIBLE CUT AND JOIN ON THE ROOF SECTION OF THE VEHICLE. Engine Compartment: Battery loose.

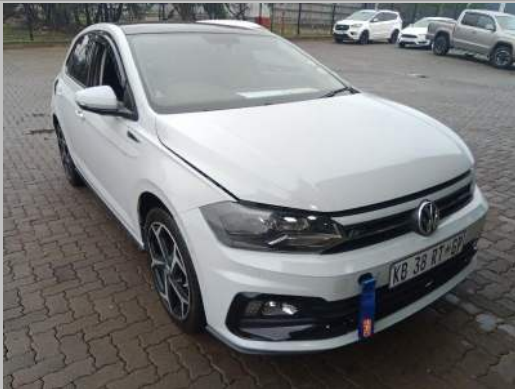
FRONT RIGHT CORNER

Body • Exterior: Minor dents and scratches and stone chips to body panels. Signs of repair work done to body panels. Poor alignment to somebody panels. Repair work done to vehicle below standard.

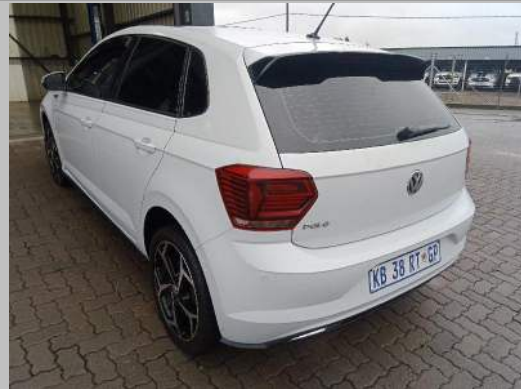
REAR LEFT CORNER

| Rear Fender Left Damaged | Repair |

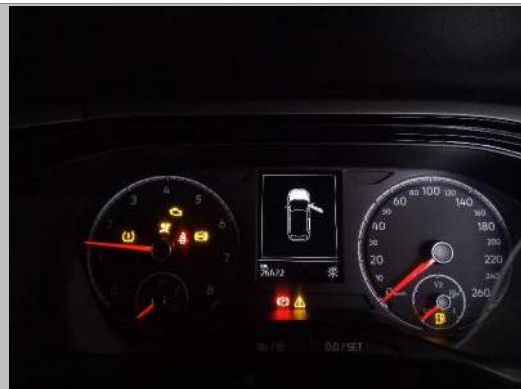
DASHBOARD (W/ ENGINE RUNNING)

| Engine Management Lights Set | Repair |

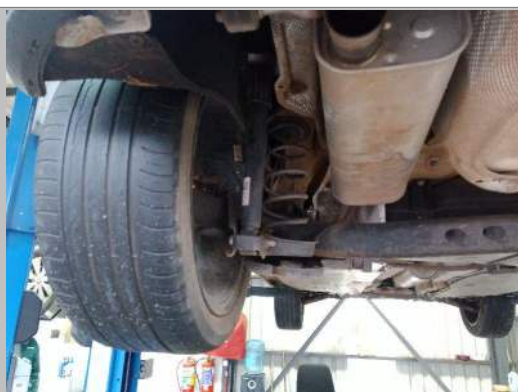
LR TYRE TREAD

| | Size | Load/Speed Index | Manufacture | Model | Type* | Production Date | Tread Depth (mm) |
|---|---|---|---|---|---|---|---|
| Rear Left | 215/45R17 | 91W | Bridgestone | Radial | V | 2119 | 1 mm |

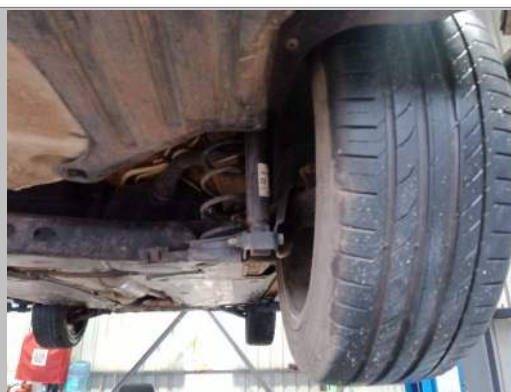
RR TYRE TREAD

| | Size | Load/Speed Index | Manufacture | Model | Type* | Production Date | Tread Depth (mm) |
|---|---|---|---|---|---|---|---|
| Rear Right | 215/45R17 | 91V | Continental | Contisport | V | 2118 | 1 mm |

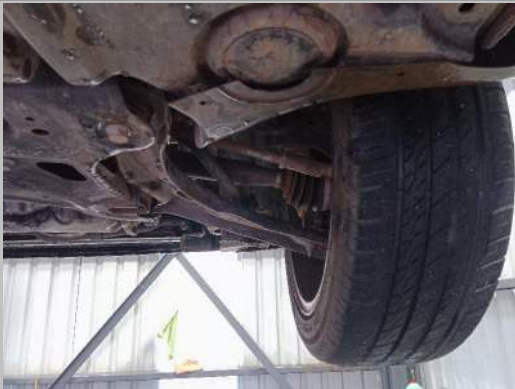
RF TYRE TREAD

| | Size | Load/Speed Index | Manufacture | Model | Type* | Production Date | Tread Depth (mm) |
|---|---|---|---|---|---|---|---|
| Front Right | 215/45R17 | 91W | Sailwin | Radial | V | 4121 | 2 mm |

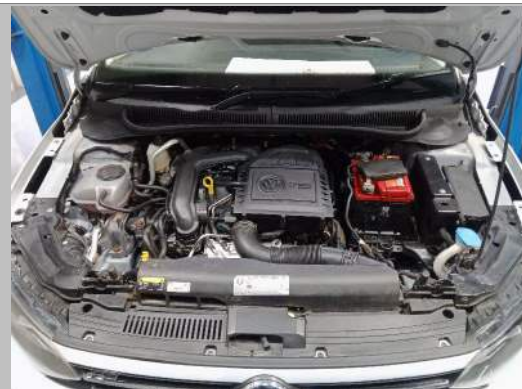
ENGINE 1

| Engine Oil Leak | Repair |
