CONDITION REPORT

Report No: 2016407562

MFC Auction House
M57 Pretoria Rd, Glenmarais, KEMPTON PARK
Gauteng

Vehicle Type	PASSENGER VEHICLE	Registered Owner	MFC AUCTION HOUSE
Manufacturer	VOLKSWAGEN	Registration Number	FMC704L
Model	POLO TSI	Register Number	
VIN	AAVZZZAWZKU082438	Date Of First Licensing	
Engine Number		Last COR	
Doors	5	License Expiry Date	31/12/2022
Color	WHITE	Power / Displacement	
Year Model		Paint Finish	TWO COAT METALLIC
Km Reading	66,128 KM	Fuel	PETROL
Cab / Body Type	HATCHBACK	Transmission	MANUAL

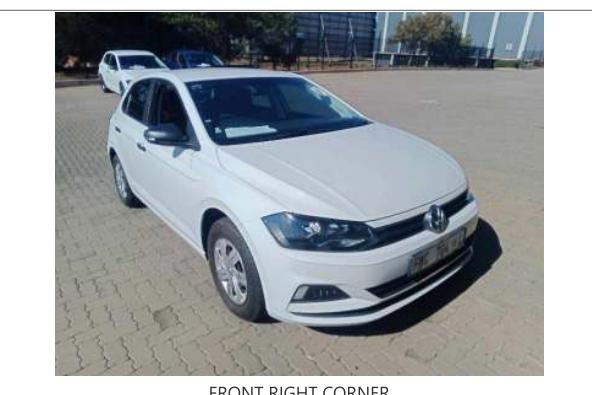
FRONT RIGHT CORNER

Damage	Repair Way
Engine Management Lights Set	Repair
Front Bumper Damaged	Repair
Bonnet Damaged	Repair
Front Fender Left Damaged	Repair
Rear Fender Left Damaged	Repair
Rear bumper Damaged	Repair
Body and exterior	Signs of repair work done to somebody panels.
Body and exterior	Poor alignment to somebody panels.
Undercarriage	Bottom of engine and gearbox fully cover.

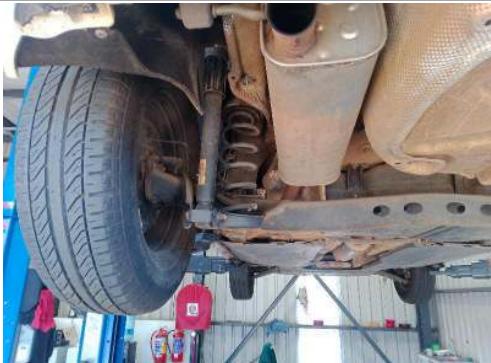
LR TYRE TREAD

Size	Load/Speed Index	Manufacture	Model	Type*	Production Date	Tread Depth (mm)
Front Left	185/70R14	88H	Falken	Radial	V	1319	2 mm
Front Right	185/70R14	88T	Dunlop	Sp	V	1820	3 mm
Rear Left	185/70R14	88T	Dunlop	Sp	V	1820	3 mm
Rear Right	185/70R14	88T	Dunlop	Radial	V	1820	3 mm
