## CONDITION REPORT

Report No:  
2017304915  
DATE  
29/09/2026

| Manufacturer | VOLKSWAGEN | Registration Number | LF95JWGP |
| Model | POLO 1.0 TSI 70KW COMFORTLINE 5-DR [2019-2021] | Register Number | |

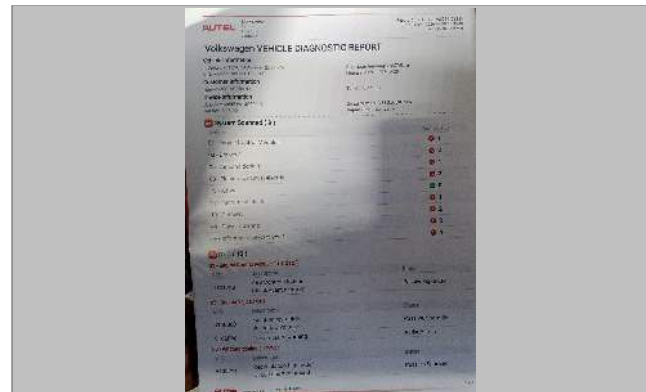
Diagnostic.

During the diagnostic no active error messages were detected. (See also attached Diagnostic Report. For more information regarding the Fault Codes (DTC) and the recommended rectifications please contact the workshops of the vehicle manufacture).

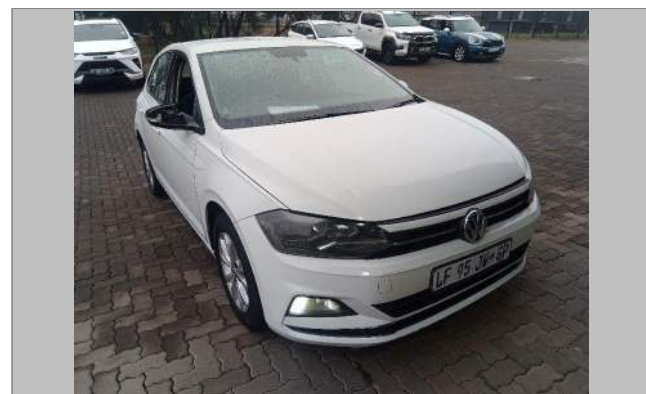
FRONT RIGHT CORNER

General Comments: ACCORDING TO THE AGE AND MILEAGE OF THE VEHICLE, NORMAL WEAR AND TEAR MARKS ARE VISIBLE ON THE INTERIOR, EXTERIOR, ELECTRICAL AND MECHANICAL PARTS. Body • Exterior: Minor dents and scratches and stone chips to body panels. Signs of repair work done to body panels. Poor alignment to somebody panels. Vehicle body in poor condition. Repair work done to vehicle below standard. Signs of impact damage to front of vehicle.

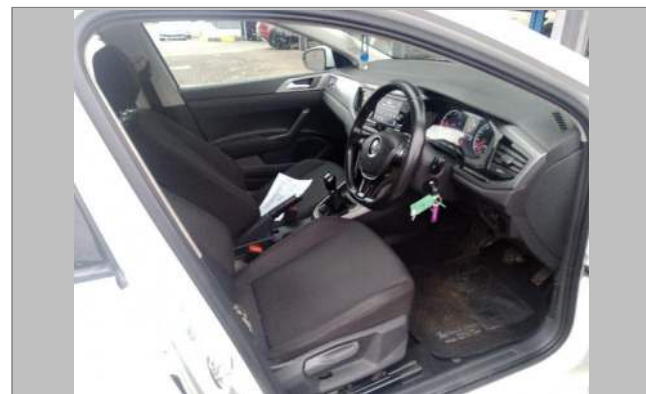
### INTERIOR (FRONT DRIVER DOOR)

| Damage | Repair Way |
|---|---|
| Switch Electrical Window Winder front right Damaged | Repair |
