CONDITION REPORT

Report No:  
2017306222  
DATE  
01/10/2026

| Manufacturer | VOLKSWAGEN | Registration Number | CXR985NC |
| Model | POLO 1.0 TSI 70KW COMFORTLINE 5-DR [2020-2022] | Register Number | |

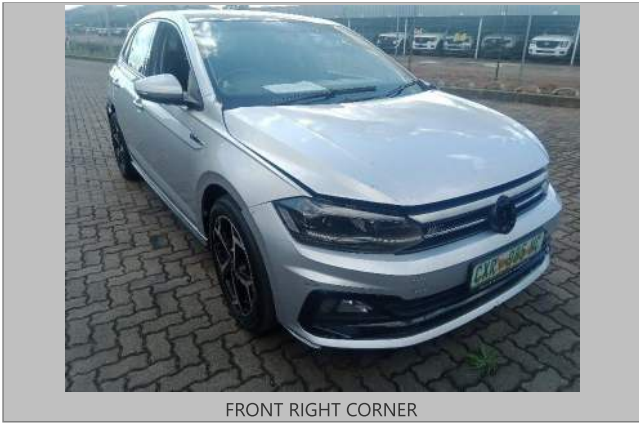
FRONT RIGHT CORNER

General Comments: ACCORDING TO THE AGE AND MILEAGE OF THE VEHICLE, NORMAL WEAR AND TEAR MARKS ARE VISIBLE ON THE INTERIOR, EXTERIOR, ELECTRICAL AND MECHANICAL PARTS. 79 DTC'S AT TIME OF TESTING SEE DTC REPORT. Engine Compartment: Foreign substance on oil filler cap. Battery loose. Electrical Components and Instruments: vehicle electronics malfunctioning.  
Body • Exterior: Minor dents and scratches and stone chips to body panels. Signs of repair work done to body panels. Poor alignment to somebody panels. Vehicle body in poor condition. Signs of impact damage to front of vehicle.
