## CONDITION REPORT

Report No:  
2017305926  
DATE  
01/10/2026

| Manufacturer | VOLKSWAGEN | Registration Number | NONE |
| Model | POLO 2.0 TSI 147KW GTI 5-DR DSG [2020-2022] | Register Number | |

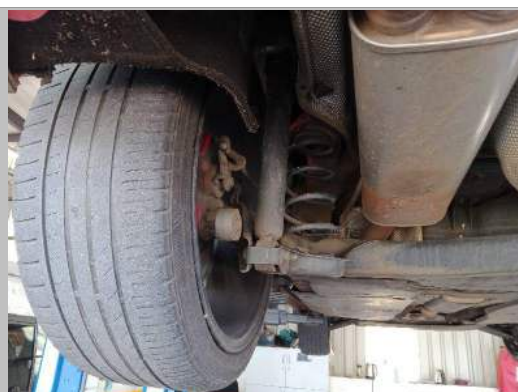
LR TYRE TREAD

| Tyre Rear Left Worn | Replace |

| | Size | Load/Speed Index | Manufacture | Model | Type* | Production Date | Tread Depth (mm) |
|---|---|---|---|---|---|---|---|
| Rear Left | 215/40Z R18 | 89W | Winrun | Radial | V | 1521 | 0 mm |

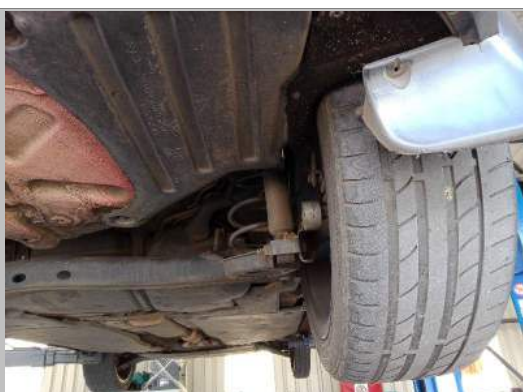
RR TYRE TREAD

| Tyre Rear Right Worn | Replace |

| | Size | Load/Speed Index | Manufacture | Model | Type* | Production Date | Tread Depth (mm) |
|---|---|---|---|---|---|---|---|
| Rear Right | 225/45Z R19 | 95W | Wanli | Sport | V | 3219 | 0 mm |
