## CONDITION REPORT

Report No:  
2017302310  
DATE  
22/09/2026

| Manufacturer | VOLKSWAGEN | Registration Number | JY31DZGP |
| Model | POLO 1.0 TSI 70KW COMFORTLINE 5-DR DSG [2020-2022] | Register Number | |

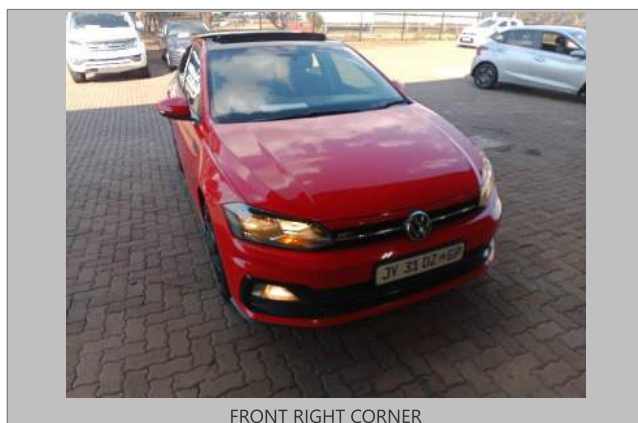
FRONT RIGHT CORNER

| Switch Electrical Window Winder front right Malfunction | Repair |
| A • Pillar Right Paintwork • Scratched | Repair |
| Front Fender Right Paintwork • Chipmarks | Repair |
| Door Front Right Paintwork • Scratched | Repair |

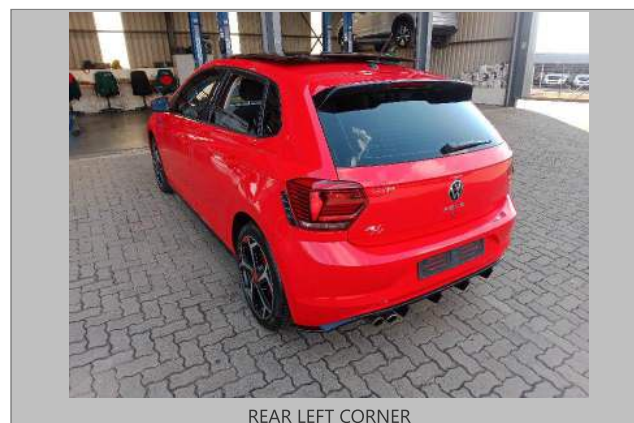
REAR LEFT CORNER

| Rear Fender Left Dented | Repair |
| Door Rear Left Paintwork • Scratched | Repair |

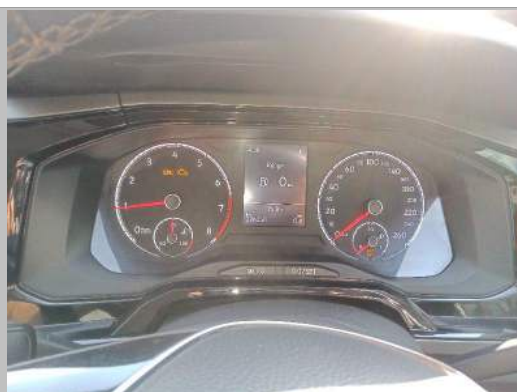
DASHBOARD (W/ ENGINE RUNNING)

| Engine management lights illuminated | Repair |

| No | System | Code | Description | Status |
|---|---|---|---|---|
| 1 | ACTIVE STATIC | P256400 | TURBOCHARGER BOOST CONTROL POSITION SENSOR CIRC LO | |

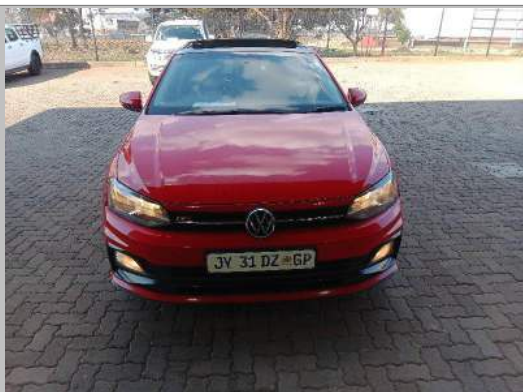
90 DEGREE FRONT

| Front Bumper Paintwork • Scratched | Repair |
| Bonnet Paintwork • Chipmarks | Repair |
| Windscreen Damaged | Replace |

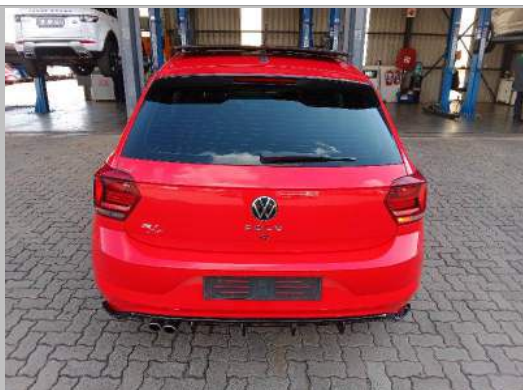
90 DEGREE REAR

| Number Plate Rear Missing | Replace |
| Boot Lid / Hatch door Paintwork • Scratched | Repair |
| Rear bumper Paintwork • Scratched | Repair |

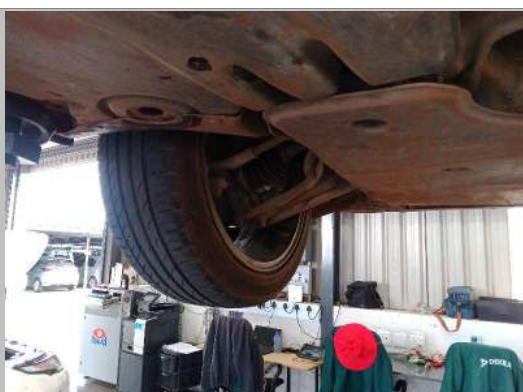
LF TYRE TREAD

| | Size | Load/Speed Index | Manufacture | Model | Type* | Production Date | Tread Depth (mm) |
|---|---|---|---|---|---|---|---|
| Front Left | 215/45R17 | 91W | Continental | Contact | V | 3725 | 3 mm |

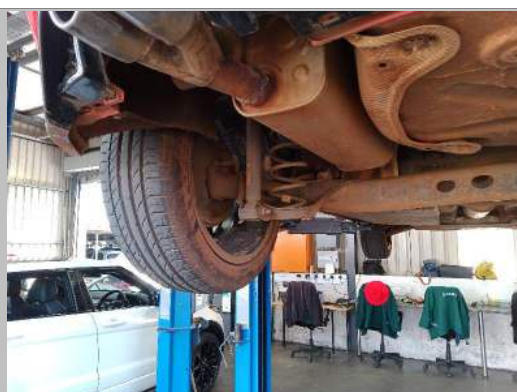
LR TYRE TREAD

| | Size | Load/Speed Index | Manufacture | Model | Type* | Production Date | Tread Depth (mm) |
|---|---|---|---|---|---|---|---|
| Rear Left | 215/45R17 | 91W | Continental | Contact | V | 3625 | 3 mm |

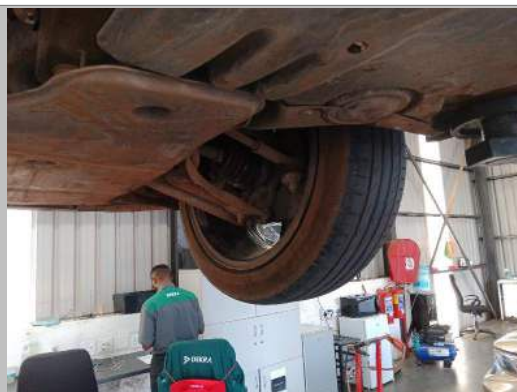
RF TYRE TREAD

| | Size | Load/Speed Index | Manufacture | Model | Type* | Production Date | Tread Depth (mm) |
|---|---|---|---|---|---|---|---|
| Front Right | 215/45R17 | 91W | Continental | Contact | V | 1724 | 3 mm |
