## CONDITION REPORT

Report No:  
2017302498  
DATE  
23/09/2026

MFC Auction House  
M57 Pretoria Rd, Glenmarais, KEMPTON PARK  
Gauteng

| Manufacturer | VOLKSWAGEN | Registration Number | HBZ487L |

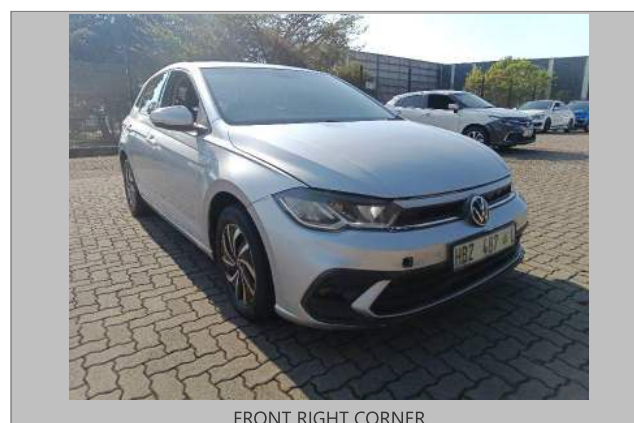
FRONT RIGHT CORNER

| Damage | Repair Way |
|---|---|
| Headlight Right Defective | Repair |
| Front Bumper Damaged | Replace |

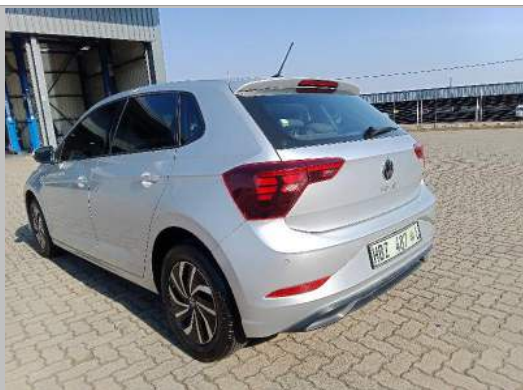
REAR LEFT CORNER

| Damage | Repair Way |
|---|---|
| Tail Light Left Cracked | Replace |
| Rear Fender Left Dented | Repair |

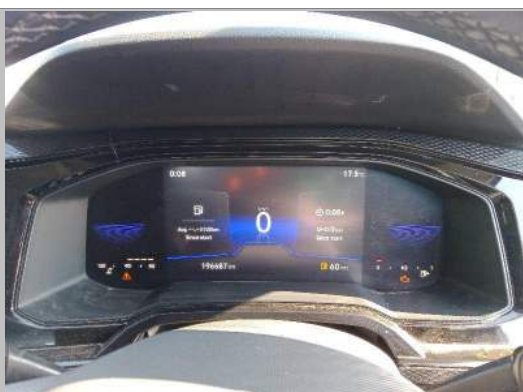
DASHBOARD (W/ ENGINE RUNNING)

| Damage | Repair Way |
|---|---|
| Engine light illuminated | Repair |

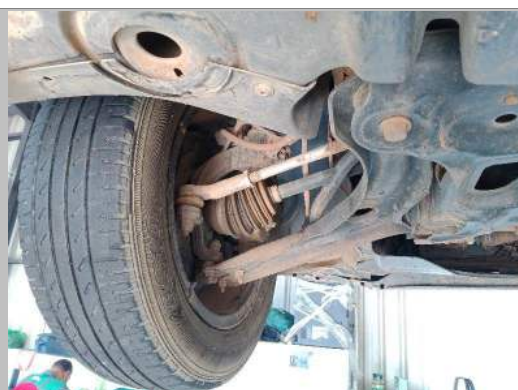
LF TYRE TREAD

| Damage | Repair Way |
|---|---|
| Tyre Front Left Damaged | Replace |
| Front and rear tyres regrooved | Replace |

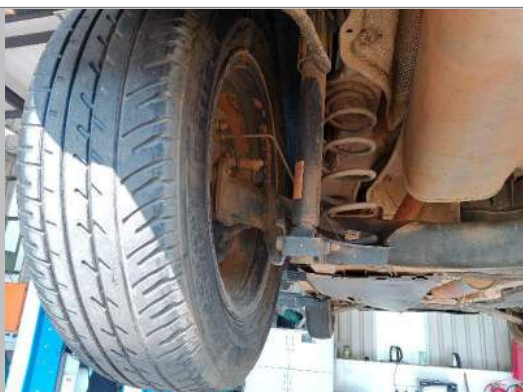
LR TYRE TREAD

| Damage | Repair Way |
|---|---|
| Tyre Rear Left Damaged | Replace |

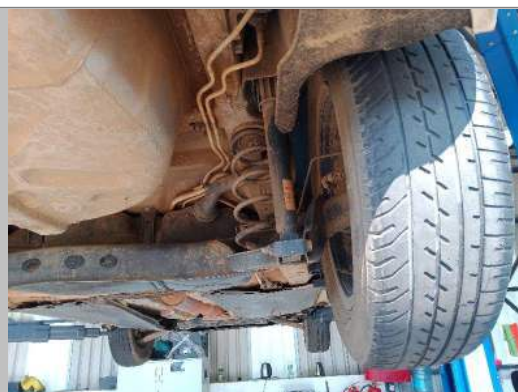
RR TYRE TREAD

| Damage | Repair Way |
|---|---|
| Tyre Rear Right Damaged | Replace |

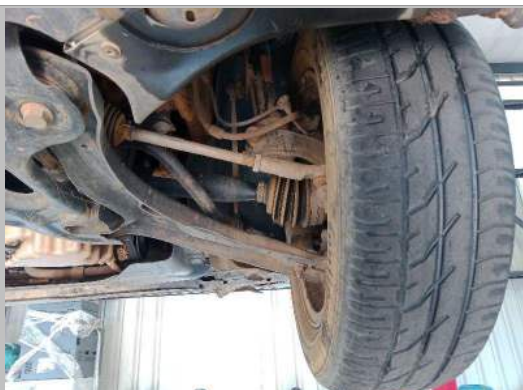
RF TYRE TREAD

| Damage | Repair Way |
|---|---|
| Tyre Front Right Damaged | Replace |

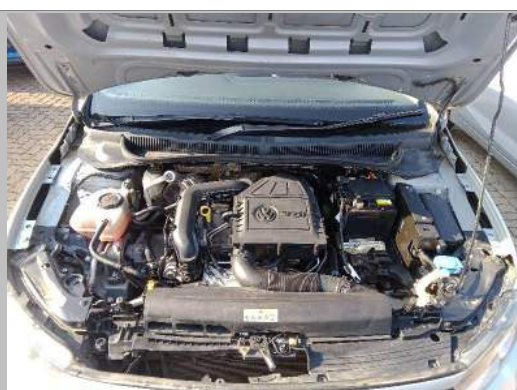
ENGINE 1

| Damage | Repair Way |
|---|---|
| Engine Oil Sweat | Repair |

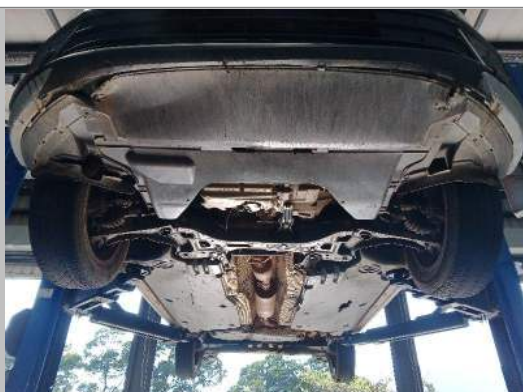
Front chassis

| Damage | Repair Way |
|---|---|
| Control Arm Bush(es) Front Axle Left Cracked | Replace |
| Control Arm Bush(es) Front Axle Right Cracked | Replace |
| Sub Frame Damaged | Repair |

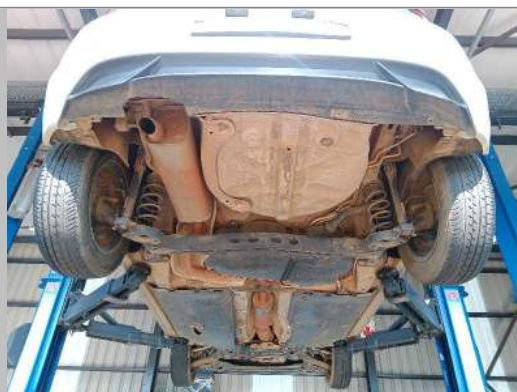
Rear chassis

| Damage | Repair Way |
|---|---|
| Cross Member Rear Right Damaged | Repair |
| Fuel Tank Damaged | Repair |
