## CONDITION REPORT

Report No:  
2017295710  
DATE  
08/09/2026

| Manufacturer | VOLKSWAGEN | Registration Number | HCL866L |
| Model | POLO TSI | Register Number | |

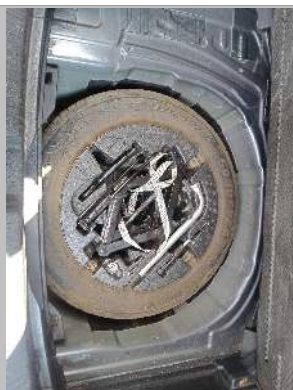
Spare wheel

| | Size | Load/Speed Index | Manufacture | Model | Type* | Production Date | Tread Depth (mm) |
|---|---|---|---|---|---|---|---|
| Spare | 195/65R15 | 88H | Goodyear | Efficient gr | V | 0000 | 3 mm |

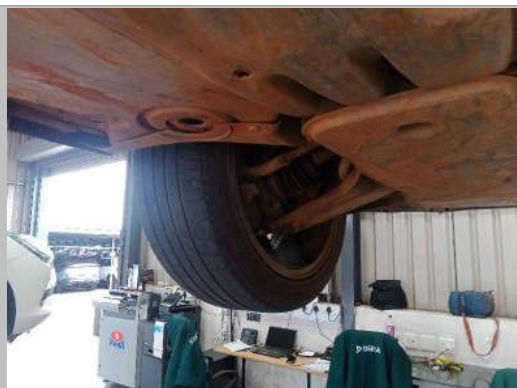
LF TYRE TREAD

| | Size | Load/Speed Index | Manufacture | Model | Type* | Production Date | Tread Depth (mm) |
|---|---|---|---|---|---|---|---|
| Front Left | 215/45R17 | 91W | Dunlop | Sp sport | V | 2624 | 3 mm |

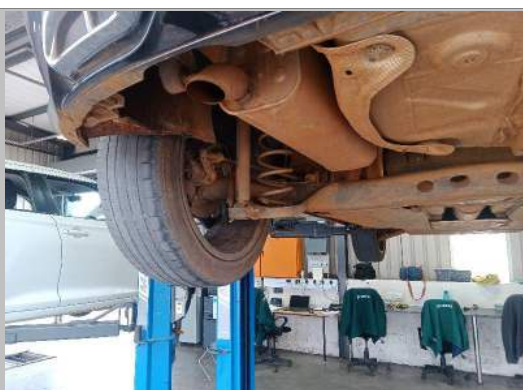
LR TYRE TREAD

| | Size | Load/Speed Index | Manufacture | Model | Type* | Production Date | Tread Depth (mm) |
|---|---|---|---|---|---|---|---|
| Rear Left | 215/45R17 | 91W | Continental | Contact | V | 3523 | 3 mm |

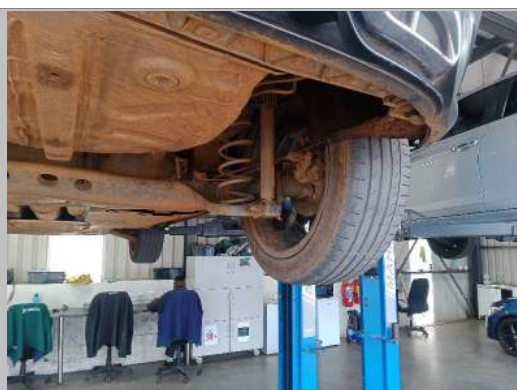
RR TYRE TREAD

| | Size | Load/Speed Index | Manufacture | Model | Type* | Production Date | Tread Depth (mm) |
|---|---|---|---|---|---|---|---|
| Rear Right | 215/45R17 | 91W | Continental | Contact | V | 3123 | 3 mm |

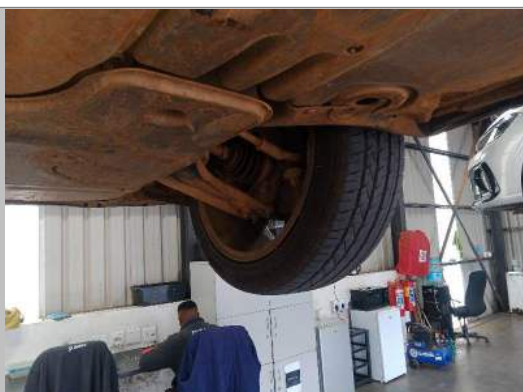
RF TYRE TREAD

| | Size | Load/Speed Index | Manufacture | Model | Type* | Production Date | Tread Depth (mm) |
|---|---|---|---|---|---|---|---|
| Front Right | 215/45R17 | 91W | Fronway | Eurus 08 | V | 1426 | 3 mm |
