MFC Auction House
M57 Pretoria Rd, Glenmarais, KEMPTON PARK
Gauteng

Vehicle Type	LIGHT LOAD VEHICLE	Registered Owner	
Manufacturer	ISUZU	Registration Number	KBD980MP
Model	D-MAX 250C FLEETSIDE DSL PU [2020-2020]	Register Number	
VIN	ACVMRRAR1J4045222	Date Of First Licensing	
Engine Number		Last COR	
Doors	2	License Expiry Date	
Color	WHITE	Power / Displacement	
Year Model	2020	Paint Finish	TWO COAT UNI
Km Reading	187,322 KM	Fuel	DIESEL
Cab / Body Type	SINGLE CAB	Transmission	MANUAL

CONDITION REPORT

Report No:
2016918298
DATE
19/06/2025

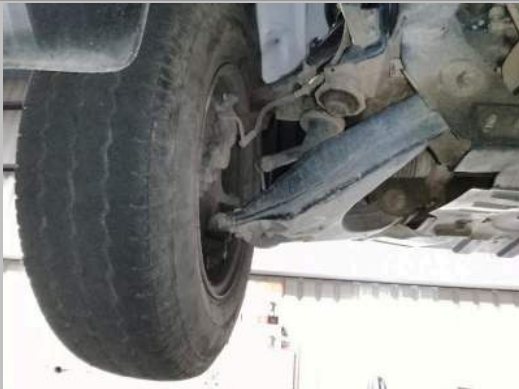
LF TYRE TREAD

Size	Load/Speed Index	Manufacture	Model	Type*	Production Date	Tread Depth (mm)
Front Left	205R16C	110Q	Sunfull	Radial	V	2422	1 mm
Front Right	205R16C	110Q	Sunful	SF-05	V	2422	1 mm
Rear Left	245/75 R16	111S	Jk tyre	Elanzo	V	4221	1 mm
Rear Right	245/75 R16	111S	Jk tyre	Elanzo	V	4821	3 mm
Spare	205/75 R16C	113R	Continental	ContiVan	V	0000	0 mm
