CONDITION REPORT

Report No:
2016919282
DATE
20/06/2025

Vehicle Type	LIGHT LOAD VEHICLE	Registered Owner	MFC AUCTION HOUSE
Manufacturer	ISUZU	Registration Number	FVM476L
Model	D-MAX 1.9 DDI HR L D-CAB DSL PU [2022-2023]	Register Number	
		Date Of First Licensing	
VIN	ACVTFR87JMD096494	Last COR	
Engine Number		License Expiry Date	31/07/2025
Doors	4	Power / Displacement	
Color	GREY	Paint Finish	TWO COAT METALLIC
Year Model	2022	Fuel	DIESEL
Km Reading	115,015 KM	Transmission	MANUAL
Cab / Body Type	DOUBLE CAB

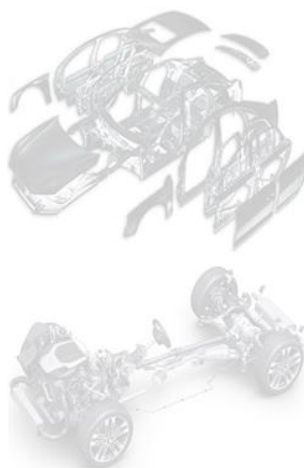
Damage	Repair Way
Seat Front Right Damaged	Repair
Front Bumper Damaged	Repair
Rear Fender Left Damaged	Repair
Rear Fender Right Damaged	Repair
Door Front Left Damaged	Repair
Door Rear Left Damaged	Repair
Door Rear Right Damaged	Repair
Tailgate Damaged	Repair
Rear bumper Damaged	Repair
Tyre Front Right Worn	Replace
