CONDITION REPORT

Report No:
2016993104
DATE
27/08/2025

Vehicle Type	LIGHT LOAD VEHICLE	Registered Owner	MFC
Manufacturer	CHEVROLET	Registration Number	FY78MDGP
Model	UTILITY 1.4 UTEFORCE EDITION PU [2014-2017]	Register Number	
VIN	ADMCF4MR0J4813797	Date Of First Licensing	
Engine Number		Last COR	
Doors	2	License Expiry Date	31/07/2025
Color	SILVER	Power / Displacement	
Year Model	2017	Paint Finish	TWO COAT METALLIC
Km Reading	43,400 KM	Fuel	PETROL
Cab / Body Type	SINGLE CAB	Transmission	MANUAL

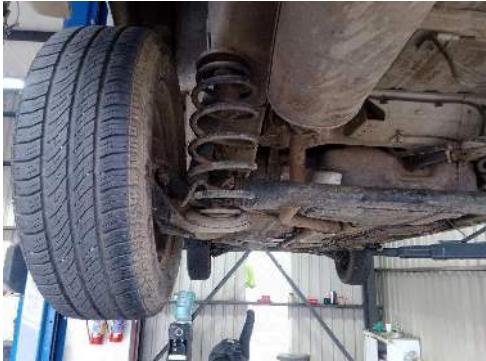
LR TYRE TREAD

Size	Load/Speed Index	Manufacture	Model	Type*	Production Date	Tread Depth (mm)
Front Left	185/65R14	86H	Goodyear	Duragrip	V	0713	2 mm
Front Right	185/65R14	86H	Goodyear	Duragrip	V	0713	1 mm
Rear Left	185/60R14	82H	Continental	Contieco	V	4206	3 mm
Rear Right	185/60R14	82H	Continental	Contieco	V	0921	3 mm

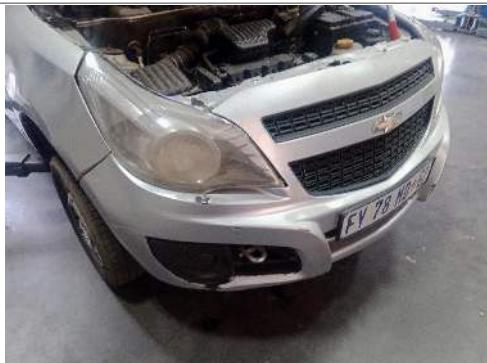
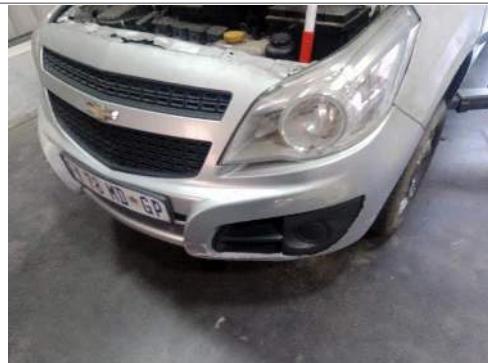
Damage	Repair Way
Engine Wiring Damaged	Repair
Hoses Damaged	Replace
Radio/CD/USB Damaged	Replace
Center Console / Cubbyhole + Lid Damaged	Replace
Engine Management Lights Set	Repair
Tail Light Left Damaged	Replace
Tail Light Right Damaged	Replace
Headlight Left Damaged	Repair
Headlight Right Damaged	Replace
Front Bumper Damaged	Repair
Bonnet Damaged	Repair
Bonnet slam plate (Shock tower/ Inner tray) Damaged	Repair
A • Pillar Left Damaged	Repair
A • Pillar Right Damaged	Repair
B • Pillar Left Damaged	Replace
B • Pillar Right Damaged	Replace
Front Fender Left Damaged	Repair
Front Fender Right Damaged	Repair
Rear Fender Left Damaged	Repair
Rear Fender Right Damaged	Repair
Front Fender Left / Inner Tray Damaged	Repair
Front Fender Right / Inner Tray Damaged	Repair
Door Front Left Damaged	Repair
Door Front Right Damaged	Repair
Sealing / Rubber Front Door Right Damaged	Repair
Tailgate Damaged	Repair
Rear bumper Damaged	Repair

Front Bumper

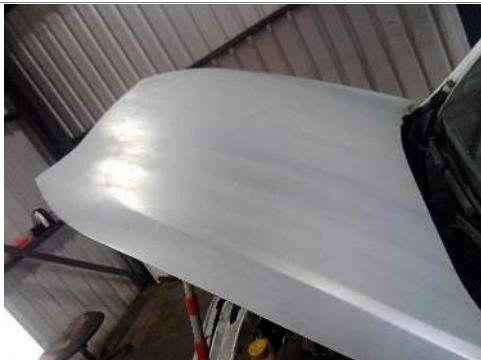
Bonnet
