## CONDITION REPORT

Report No:  
2016927175  
DATE  
27/06/2025

| Manufacturer | CHEVROLET | Registration Number | NO REG |
| Model | UTILITY 1.8 SPORT PU [2011-2017] | Register Number | |

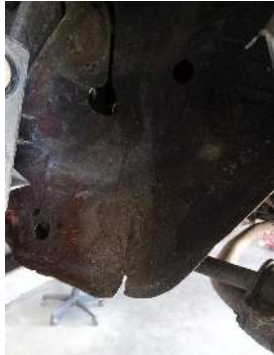
| Damage | Repair Way |
|---|---|
| Main Beam Left Welded | Repair |
