MFC Auction House  
M57 Pretoria Rd, Glenmarais, KEMPTON PARK  
Gauteng

## CONDITION REPORT

Report No: 2016309147

DATE  
18/03/2024

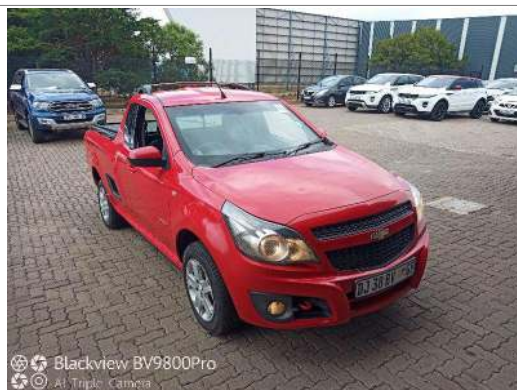
FRONT RIGHT CORNER

| Damage | Repair Way |
|---|---|
| Headlight Right Damaged | Repair |
| Side Mirror Right Damaged | Repair |

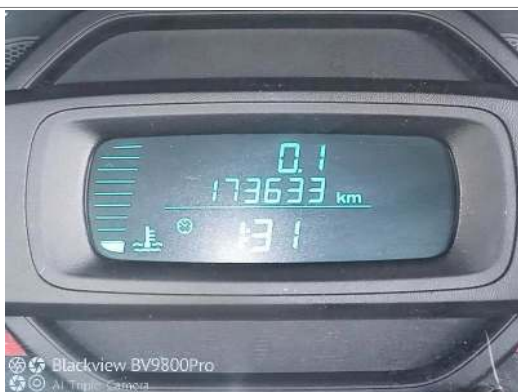
ODOMETER

| Km Reading | 173,633 KM | Fuel | PETROL |

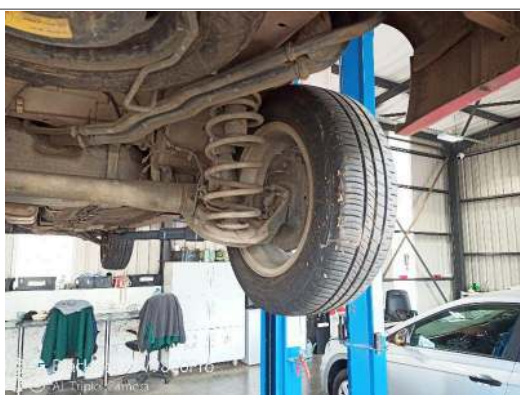
RR TYRE TREAD

| | Size | Load/Speed Index | Manufacture | Model | Type* | Production Date | Tread Depth (mm) |
|---|---|---|---|---|---|---|---|
| Rear Right | 185/65R15 | 92T | Dunlop | Sp touring | V | 4921 | 4 mm |

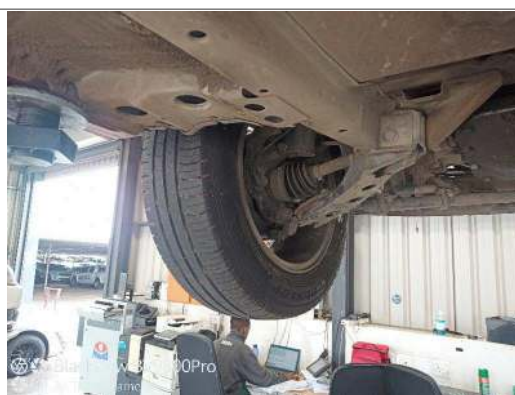
LF TYRE TREAD

| | Size | Load/Speed Index | Manufacture | Model | Type* | Production Date | Tread Depth (mm) |
|---|---|---|---|---|---|---|---|
| Front Left | 185/65R15 | 92T | Dunlop | Sp touring | V | 4421 | 4 mm |

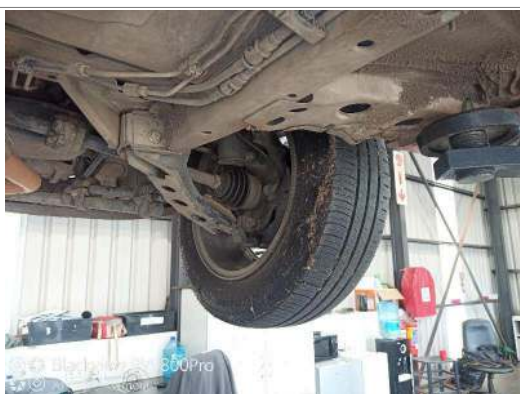
RF TYRE TREAD

| | Size | Load/Speed Index | Manufacture | Model | Type* | Production Date | Tread Depth (mm) |
|---|---|---|---|---|---|---|---|
| Front Right | 185/65R15 | 92T | Dunlop | Sp touring | V | 4421 | 4 mm |

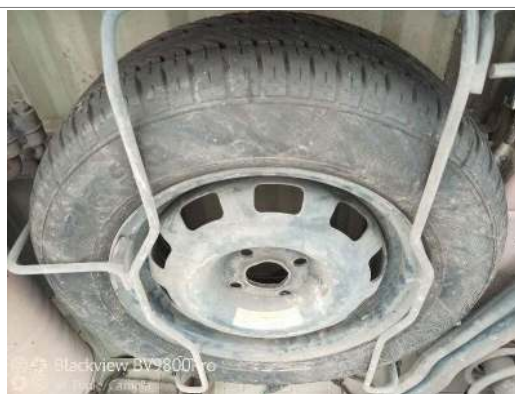
Spare wheel

| | Size | Load/Speed Index | Manufacture | Model | Type* | Production Date | Tread Depth (mm) |
|---|---|---|---|---|---|---|---|
| Spare | 185/65R14 | 86H | Dunlop | Sp sport | V | 2514 | 4 mm |

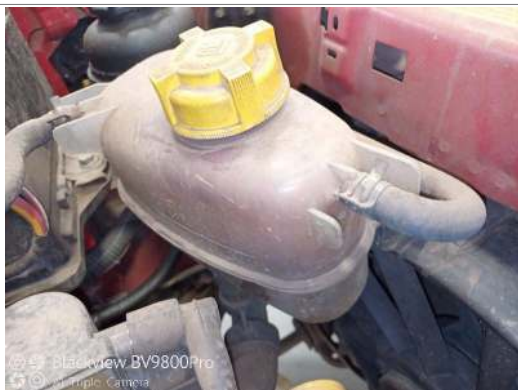
Expection bottle

| Damage | Repair Way |
|---|---|
| Expansion Bottle Defective | Replace |

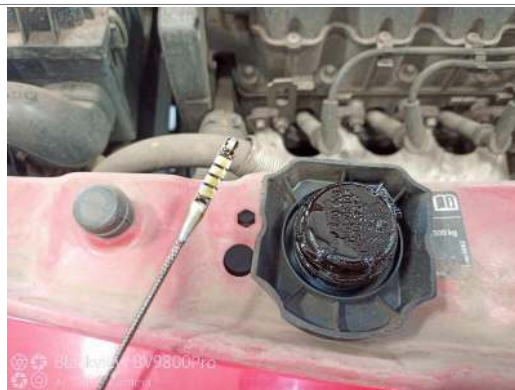
Oil cap and dipstick

| Damage | Repair Way |
|---|---|
| Engine Oil Leak | Repair |
