## CONDITION REPORT

Report No:  
2016963494  
DATE  
31/07/2025

| Manufacturer | ISUZU | Registration Number | JDY681NW |
| Model | KB300 LX 4X4 DSL PU [2013-2014] | Register Number | |

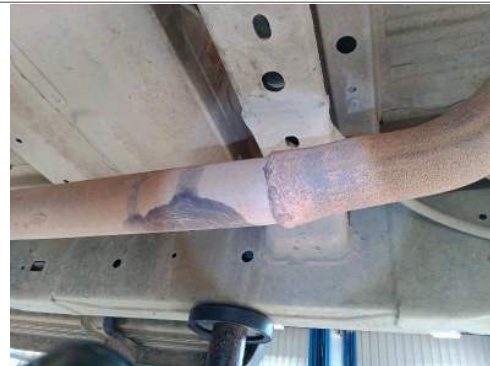
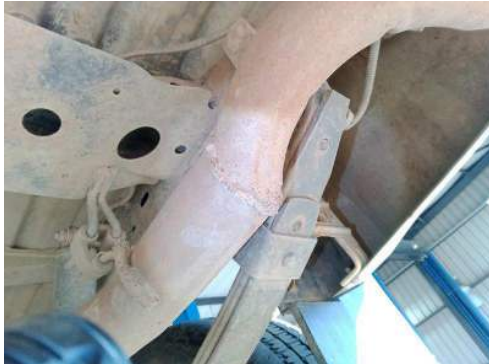
| Damage | Repair Way |
|---|---|
| Engine to silencer pipe Welded | Repair |

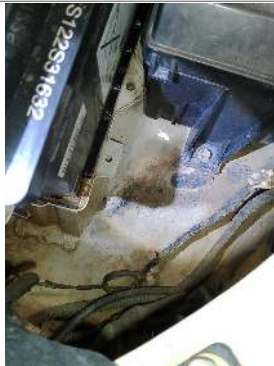
| Damage | Repair Way |
|---|---|
| Front Fender Left / Inner Tray Welded | Repair |
