## CONDITION REPORT

Report No:  
2016958074  
DATE  
25/07/2025

| Manufacturer | CHEVROLET | Registration Number | JCL625MP |
| Model | CORSA 1.4 CLUB UTILITY PU [2010-2012] | Register Number | |

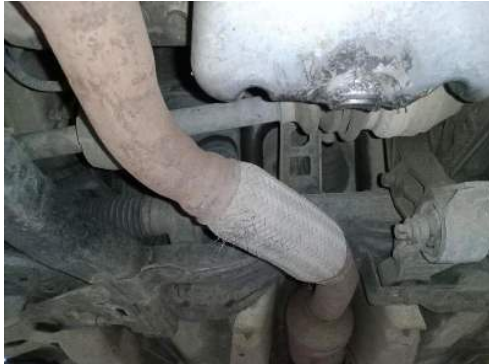
| Damage | Repair Way |
|---|---|
| Engine to silencer pipe Defective | Repair |
