MFC Auction House
M57 Pretoria Rd, Glenmarais, KEMPTON PARK
Gauteng

VEHICLE INSPECTION

CONDITION REPORT

Report No: 2016309471

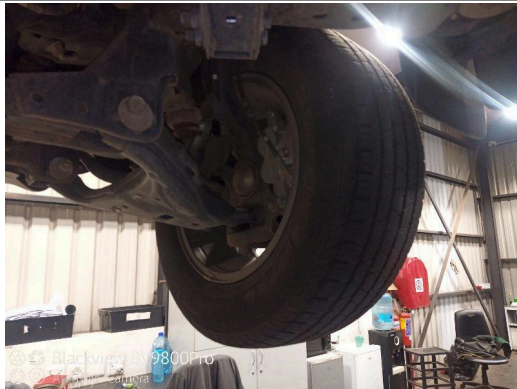
RF TYRE TREAD

Size	Load/Speed Index	Manufacture	Model	Type*	Production Date	Tread Depth (mm)
Front Left	265/60R18	110T	Continental	Contact	V	4918	3 mm
Front Right	265/60R18	110T	Continental	Contact	V	4818	3 mm
Rear Left	265/60R18	110T	Continental	Contact	V	4818	3 mm
Rear Right	265/60R18	110T	Continental	Contact	V	4819	3 mm
Spare	265/65R17	112T	Continental	Contact	V	0000	6 mm

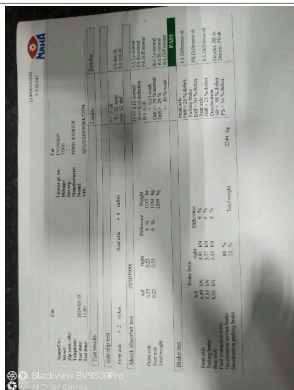
SHOCK & BRAKE REPORT

Left	Right		
	Braking Force [KN]	Braking Force [KN]	Axle Weight [KG]	Deceleration [m/s ²]
Front	4.4	4.9	-	
Rear	4.9	5.1	-	
Emergency / Parking	3.5	3.7	-

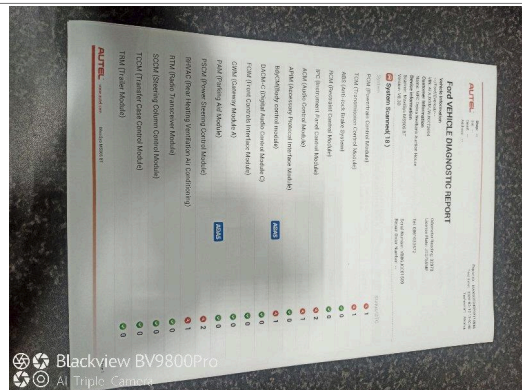
DIAGNOSTIC REPORT PAGE 1

During the diagnostic no active error messages were detected. (See also attached Diagnostic Report. For more information regarding the Fault Codes (DTC) and the recommended rectifications please contact the workshops of the vehicle manufacture).
