## CONDITION REPORT

Report No: 2016388044

DATE  
22/05/2024

| Manufacturer | FORD | Registration Number | FKN035L |

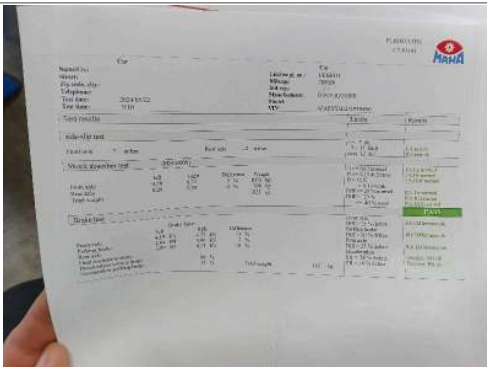
Brake and shock test

| | Left | Right | | |
|---|---|---|---|---|
| Front | 4.19 | 4.73 | - | |
| Rear | 3.89 | 4.33 | - | |
| Emergency / Parking | 2.84 | 3.06 | - | |

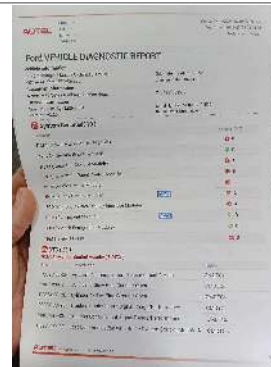
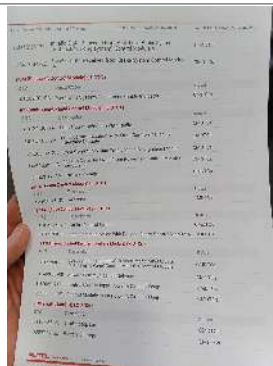
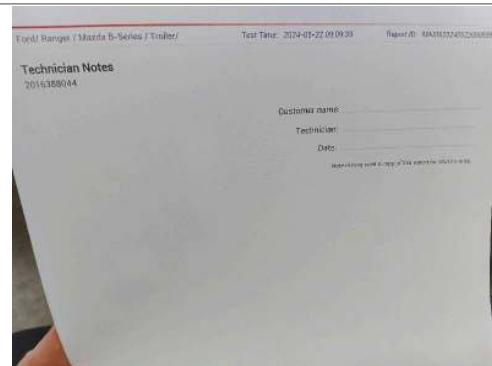
Diagnostic report

During the diagnostic no active error messages were detected. (See also attached Diagnostic Report. For more information regarding the Fault Codes (DTC) and the recommended rectifications please contact the workshops of the vehicle manufacture).

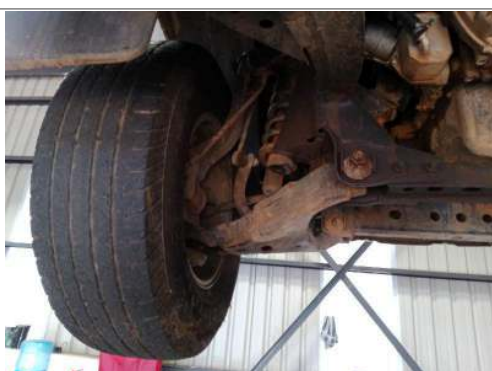
LF TYRE TREAD

| Damage | Repair Way |
|---|---|
| Tyre Front Left Worn | Replace |

| | Size | Load/Speed Index | Manufacture | Model | Type* | Production Date | Tread Depth (mm) |
|---|---|---|---|---|---|---|---|
| Front Left | 225/70R16 | 111T | Continental | Crosscontact | V | 2516 | 0 mm |

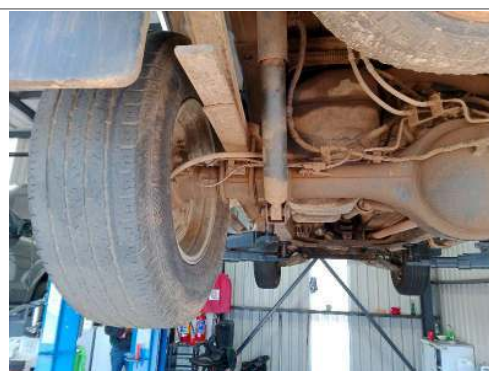
LR TYRE TREAD

| | Size | Load/Speed Index | Manufacture | Model | Type* | Production Date | Tread Depth (mm) |
|---|---|---|---|---|---|---|---|
| Rear Left | 225/70R16 | 111T | Continental | Crosscontact | V | 1616 | 2 mm |

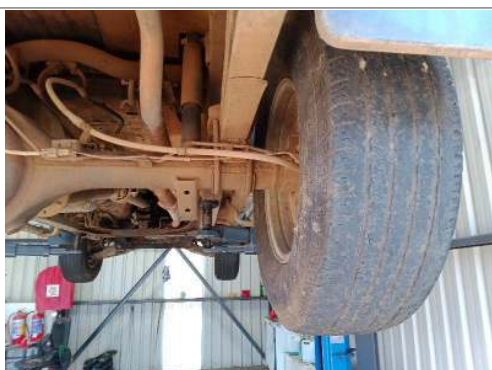
RR TYRE TREAD

| Damage | Repair Way |
|---|---|
| Tyre Rear Right Worn | Replace |

| | Size | Load/Speed Index | Manufacture | Model | Type* | Production Date | Tread Depth (mm) |
|---|---|---|---|---|---|---|---|
| Rear Right | 255/70R16 | 111T | Continental | Crosscontact | V | 2516 | 0 mm |

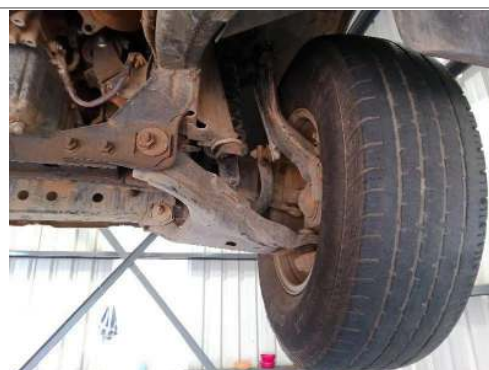
RF TYRE TREAD

| | Size | Load/Speed Index | Manufacture | Model | Type* | Production Date | Tread Depth (mm) |
|---|---|---|---|---|---|---|---|
| Front Right | 255/70R16 | 111T | Continental | Crosscontact | V | 2316 | 1 mm |
