## CONDITION REPORT

Report No:  
2017303136  
DATE  
25/09/2026

| Manufacturer | FORD | Registration Number | KPV873MP |
| Model | RANGER 2.2 TDCI XL D-CAB DSL PU [2017-2020] | Register Number | |

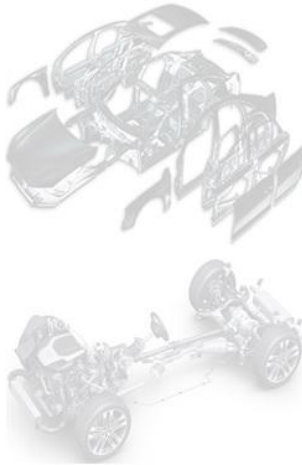
| Damage | Repair Way |
|---|---|
| Engine Oil Leak | Repair |
| Tail Light Right Scratched | Repair |
| Headlight Left Defective | Repair |
| Headlight Right Defective | Repair |
| Front Bumper Paintwork • Scratched | Repair |
| Bonnet Paintwork • Chipmarks | Repair |
| Front Fender Left Damaged | Repair |
| Front Fender Right Paintwork • Chipmarks | Repair |
| Rear Fender Left Damaged | Repair |
| Rear Fender Right Paintwork • Scratched | Repair |
| Door Front Left Dented | Repair |
| Door Front Right Paintwork • Scratched | Repair |
| Door Rear Left Paintwork • Scratched | Repair |
| Tailgate Paintwork • Scratched | Repair |
| Rear bumper Damaged | Repair |
| Roof Dented | Repair |
| Load Body Damaged | Repair |
| Windscreen Chipped | Repair |
