MFC Auction House
M57 Pretoria Rd, Glenmarais, KEMPTON PARK
Gauteng

Vehicle Type	PASSENGER VEHICLE	Registered Owner	MFC AUCTION HOUSE
Manufacturer	TOYOTA	Registration Number	KVK699MP
Model	COROLLA	Register Number	
VIN	AHTBBOJE000006994	Date Of First Licensing	
Engine Number		Last COR	
Doors	4	License Expiry Date	31/03/2024
Color	SILVER	Power / Displacement	
Year Model		Paint Finish	M - METALLIC
Km Reading	185,437 KM	Fuel	PETROL
Cab / Body Type	SEDAN	Transmission	MANUAL

CONDITION REPORT

Report No: 2016368511

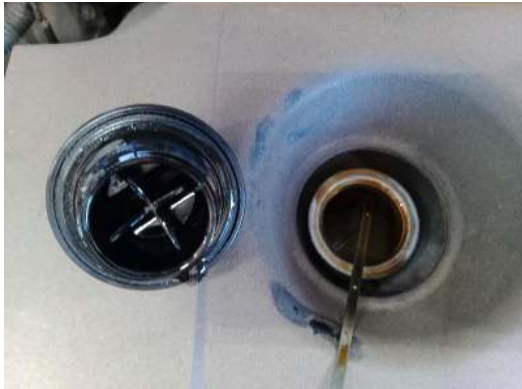
Oil cap and dipstick

Damage	Repair Way
Engine Oil Sweat	Repair
Front Bumper Paintwork • Scratched	Repair
Bonnet Dented	Repair
C • Pillar Left Dented	Repair
Front Fender Right Paintwork • Runners / Teardrops	Repair
Door Front Left Paintwork • Runners / Teardrops	Repair
Door Rear Left Paintwork • Runners / Teardrops	Repair
Rear bumper Paintwork • Scratched	Repair
Sill Panel Right Paintwork • Runners / Teardrops	Repair
Roof Dented	Repair
Gearbox Oil Sweat	Repair
CV Joint(s) Boot(s) Front Right (inner/outer) Damaged	Replace
Gear Selections Malfunction	Repair

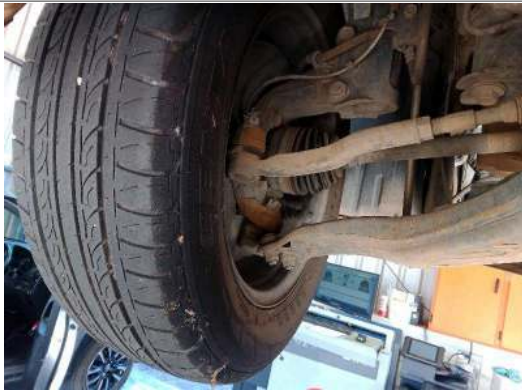
LF TYRE TREAD

Size	Load/Speed Index	Manufacture	Model	Type*	Production Date	Tread Depth (mm)
Front Left	195/65R15	91V	Centara	Vanti tourin	V	1622	4 mm
Front Right	195/65R15	91V	Centara	Vanti tourin	V	1622	5 mm
Rear Left	195/65R15	91V	Centara	Vanti tourin	V		6 mm
Rear Right	195/65R15	91V	Sumitomo	BC100	V	0928	6 mm
Spare	195/65R15	91V	Roadking	Radial	V	////////	1 mm
