CONDITION REPORT

Report No:  
2017297912  
DATE  
11/09/2026

| Manufacturer | TOYOTA | Registration Number | MD92JFGP |
| Model | COROLLA QUEST 1.8 PLUS [2022-2025] | Register Number | |

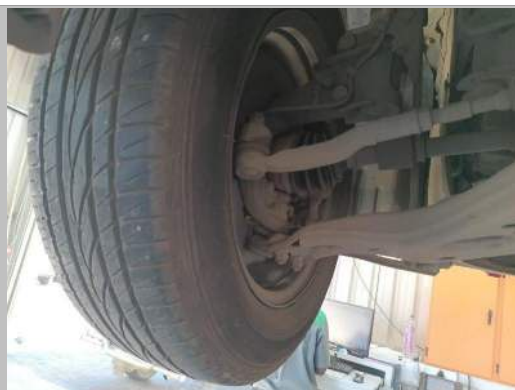
LF TYRE TREAD

| | Size | Load/Speed Index | Manufacture | Model | Type* | Production Date | Tread Depth (mm) |
|---|---|---|---|---|---|---|---|
| Front Left | 195/65R15 | 91V | Sumitomo | BC100 | V | 0725 | 5 mm |

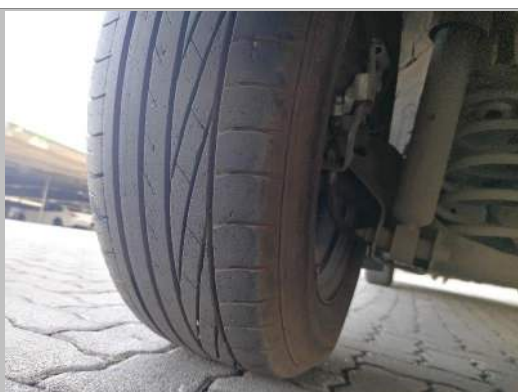
LR TYRE TREAD

| | Size | Load/Speed Index | Manufacture | Model | Type* | Production Date | Tread Depth (mm) |
|---|---|---|---|---|---|---|---|
| Rear Left | 195/65R15 | 91H | Goodyear | Excellence | V | 4023 | 6 mm |

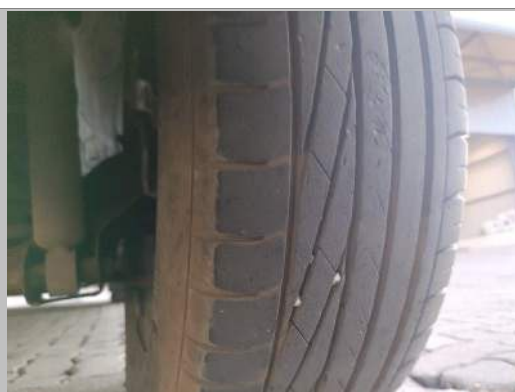
RR TYRE TREAD

| | Size | Load/Speed Index | Manufacture | Model | Type* | Production Date | Tread Depth (mm) |
|---|---|---|---|---|---|---|---|
| Rear Right | 195/65R15 | 91H | Goodyear | Excellence | V | 4023 | 5 mm |

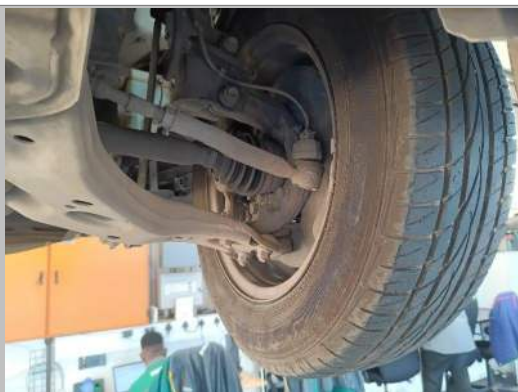
RF TYRE TREAD

| | Size | Load/Speed Index | Manufacture | Model | Type* | Production Date | Tread Depth (mm) |
|---|---|---|---|---|---|---|---|
| Front Right | 195/65R15 | 91V | Sumitomo | BC100 | V | 0725 | 5 mm |

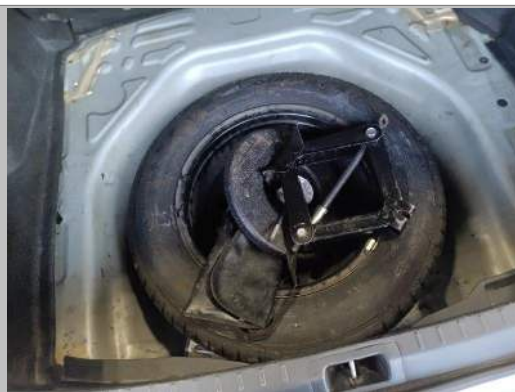
Sparewheel

| | Size | Load/Speed Index | Manufacture | Model | Type* | Production Date | Tread Depth (mm) |
|---|---|---|---|---|---|---|---|
| Spare | 195/65R15 | 91H | Goodyear | Excellence | V | 0000 | 6 mm |
