CONDITION REPORT

Report No:
2016945342
DATE
14/07/2025

| Manufacturer | TOYOTA | Registration Number | FTM730L |
| Model | HILUX 2.0 VVTI S A/C PU [2020-2022] | Register Number | |

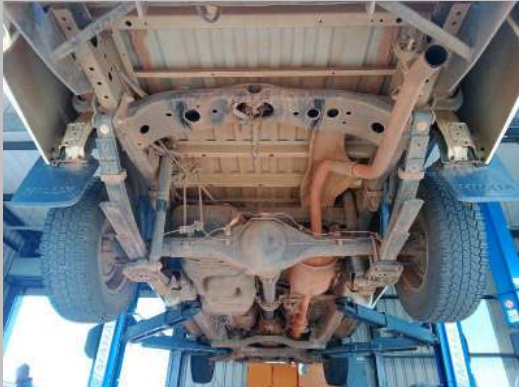
Rear end

| Damage | Repair Way |
|--|--|
| Load Body Damaged | Repair |

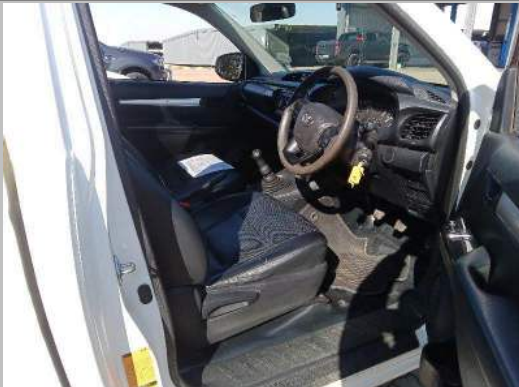
INTERIOR (FRONT DRIVER DOOR)

| Damage | Repair Way |
|--|--|
| Seat Front Right Torn / Cut | Repair |

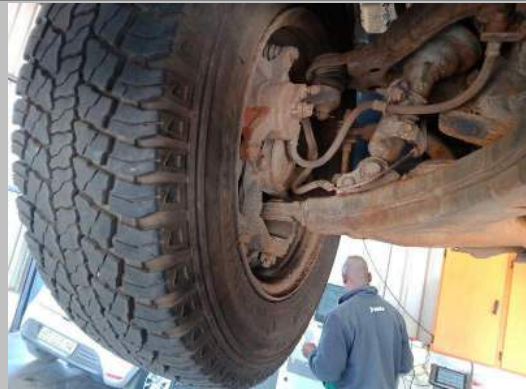
LF TYRE TREAD

| | Size | Load/Speed Index | Manufacture | Model | Type* | Production Date | Tread Depth (mm) |
|---|---|---|---|---|---|---|---|
| Front Left | 205/70R15 | 106/104S | Continental | Contact | V | 2224 | 5 mm |

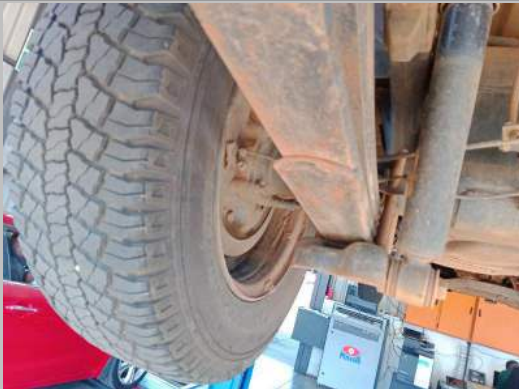
LR TYRE TREAD

| | Size | Load/Speed Index | Manufacture | Model | Type* | Production Date | Tread Depth (mm) |
|---|---|---|---|---|---|---|---|
| Rear Left | 205/70R15 | 106/104S | Continental | Contact | V | 2224 | 5 mm |

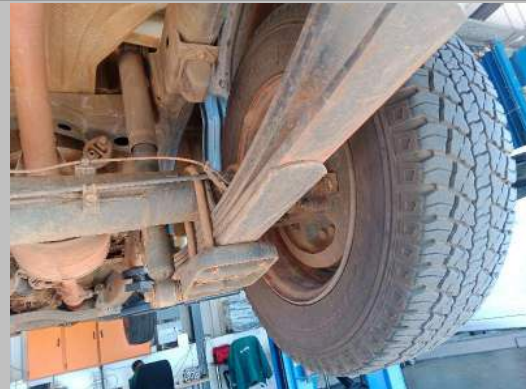
RR TYRE TREAD

| | Size | Load/Speed Index | Manufacture | Model | Type* | Production Date | Tread Depth (mm) |
|---|---|---|---|---|---|---|---|
| Rear Right | 205/70R15 | 106/104S | Continental | Contact | V | 2624 | 5 mm |

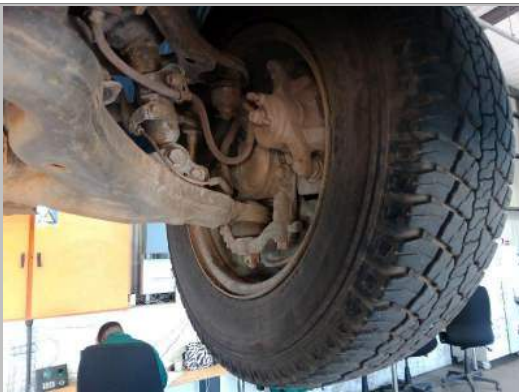
RF TYRE TREAD

| | Size | Load/Speed Index | Manufacture | Model | Type* | Production Date | Tread Depth (mm) |
|---|---|---|---|---|---|---|---|
| Front Right | 205/70R15 | 106/104S | Continental | Contact | V | 2624 | 6 mm |

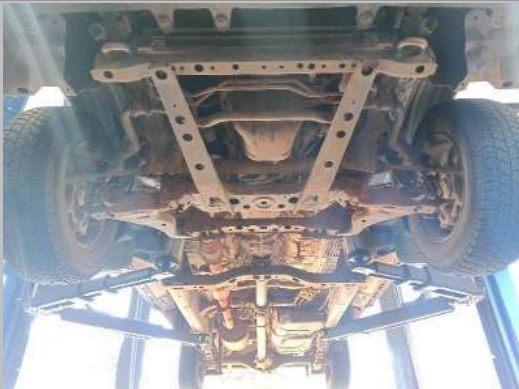
CHASSIS

| Damage | Repair Way |
|--|--|
| Undercarriage | is muddy unclear for inspection |
