## CONDITION REPORT

Report No:  
2017303410  
DATE  
25/09/2026

| Manufacturer | TOYOTA | Registration Number | LV21VCGP |
| Model | HILUX 2.4 GD-6 RB RAIDER D-CAB DSL PU [2021-2023] | Register Number | |

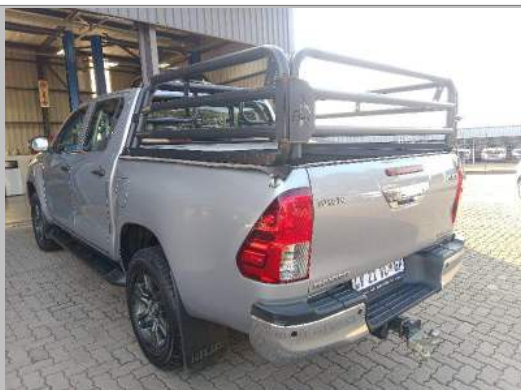
REAR LEFT CORNER

| Rear Fender Left Damaged | Repair |

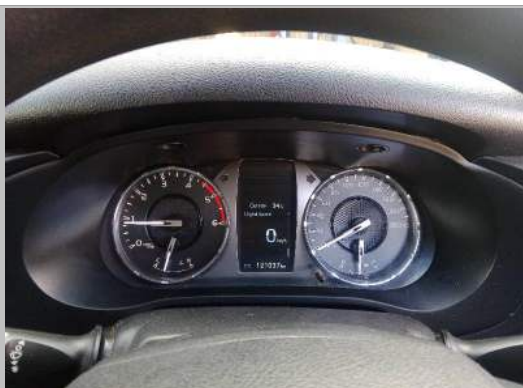
DASHBOARD (W/ ENGINE RUNNING)

| No | System | Code | Description | Status |
|---|---|---|---|---|
| 1 | COMBINATION METER | B1504 | LOST COMMUNICATION WITH HMI-LAN | |

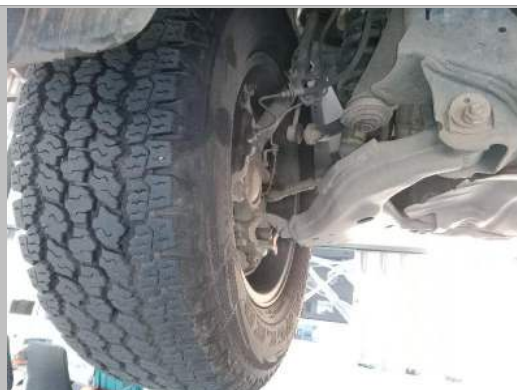
LF TYRE TREAD

| | Size | Load/Speed Index | Manufacture | Model | Type* | Production Date | Tread Depth (mm) |
|---|---|---|---|---|---|---|---|
| Front Left | 265/65 R17 | 112T | Goodyear | Wrangler | V | 0225 | 7 mm |

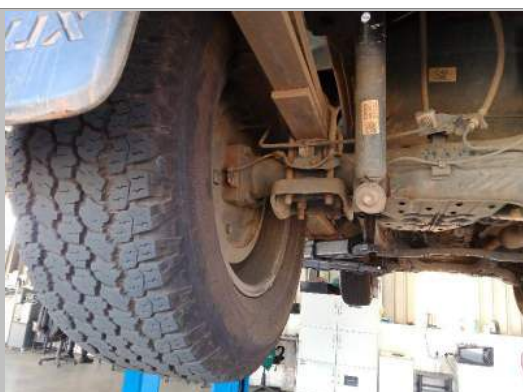
LR TYRE TREAD

| | Size | Load/Speed Index | Manufacture | Model | Type* | Production Date | Tread Depth (mm) |
|---|---|---|---|---|---|---|---|
| Rear Left | 265/65 R17 | 112T | Goodyear | Wrangler | V | 2925 | 8 mm |

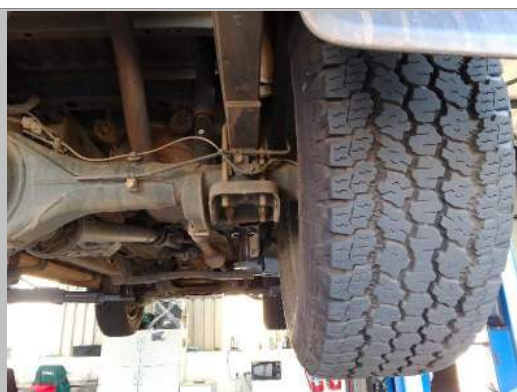
RR TYRE TREAD

| | Size | Load/Speed Index | Manufacture | Model | Type* | Production Date | Tread Depth (mm) |
|---|---|---|---|---|---|---|---|
| Rear Right | 265/65 R17 | 112T | Goodyear | Wrangler | V | 1425 | 8 mm |

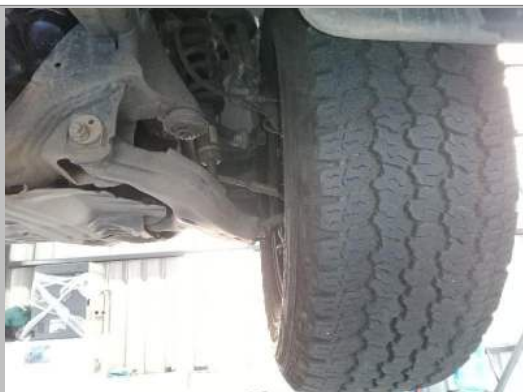
RF TYRE TREAD

| | Size | Load/Speed Index | Manufacture | Model | Type* | Production Date | Tread Depth (mm) |
|---|---|---|---|---|---|---|---|
| Front Right | 265/65 R17 | 112T | Goodyear | Wrangler | V | 4524 | 7 mm |

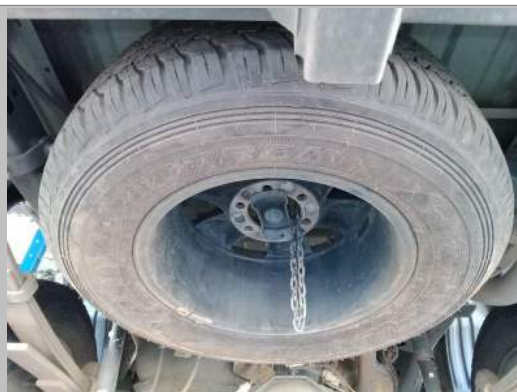
Spare tyre

| | Size | Load/Speed Index | Manufacture | Model | Type* | Production Date | Tread Depth (mm) |
|---|---|---|---|---|---|---|---|
| Spare | 265/65 R17 | 112S | Dunlop | Grandtrek | V | 0000 | 9 mm |

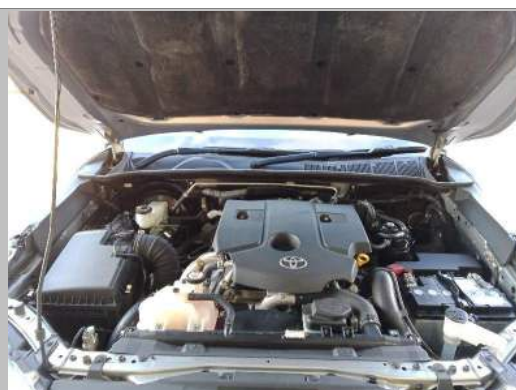
ENGINE 1

| Engine Wiring Defective | Repair |
