MFC Auction House  
M57 Pretoria Rd, Glenmarais, KEMPTON PARK  
Gauteng

DEKRA MFC  
M57 Pretoria Rd - 1619  
KEMPTON PARK - GT  
08610 33572

Vehicle Type	LIGHT LOAD VEHICLE	Registered Owner	
Manufacturer	TOYOTA	Registration Number	JZ46MFGP
Model	HILUX 2.4 GD-6 SRX 4X4 DSL PU [2016-2018]	Register Number	
VIN	AHTKB8CBX02852202	Date Of First Licensing	
Engine Number		Last COR	
Doors	2	License Expiry Date	30/04/2025
Color	WHITE	Power / Displacement	
Year Model	2017	Paint Finish	C - COMMON
Km Reading	411,372 KM	Fuel	DIESEL
Cab / Body Type	SINGLE CAB	Transmission	MANUAL

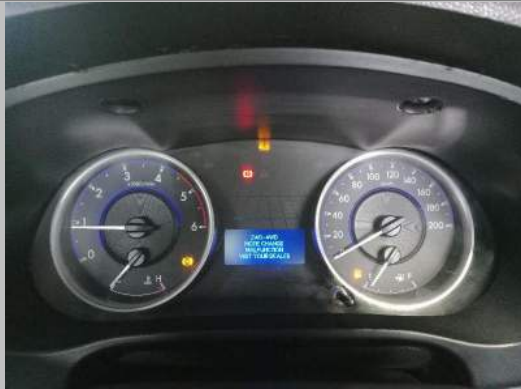
DASHBOARD (W/ ENGINE RUNNING)

Damage	Repair Way
Power Steering Pump / Electronic Unit Defective	Repair
Wiring connections Defective	Repair
Seat Front Right Torn / Cut	Repair
Front Bumper Residual Traces of Repair	Repair
Bonnet Dented	Repair
Front Fender Right Paintwork • Chipmarks	Repair
Brake Drum 2. Axle left Excessive Wear & Tear	Repair
Steering Rack Boot Left Missing	Replace
Steering Rack Boot Right Missing	Replace
Alignment Left / Right Difference out of legal range	Repair
Differential Oil Leak	Repair
Low and High Range Selection Insufficient	Repair
4x4 selection not working	Repair
Body exterior	Signs of spray work done on some body panels
Engine	Bottom of engine is fully covered
Multiple warning lights illuminated	Repair
