CONDITION REPORT

Report No:
2016918984
DATE
20/06/2025

MFC Auction House
M57 Pretoria Rd, Glenmarais, KEMPTON PARK
Gauteng

Vehicle Type	LIGHT LOAD VEHICLE	Registered Owner	MFC AUCTION HOUSE
Manufacturer	TOYOTA	Registration Number	MF09PPGP
Model	HILUX 2.4 GD-6 SRX 4X4 D-CAB DSL PU [2016-2017]	Register Number	
		Date Of First Licensing	
VIN	AHTKB8CD602961130	Last COR	
Engine Number		License Expiry Date	
Doors	4	Power / Displacement	
Color	WHITE	Paint Finish	C - COMMON
Year Model	2016	Fuel	DIESEL
Km Reading	415,219 KM	Transmission	MANUAL
Cab / Body Type	DOUBLE CAB

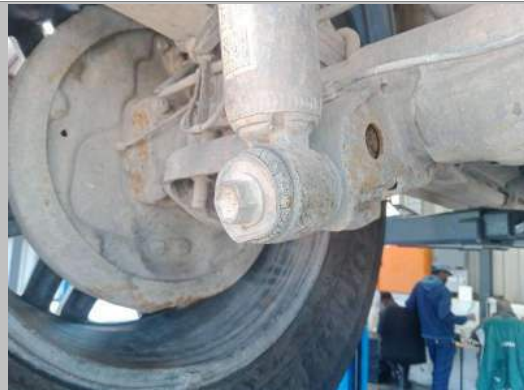
Damage	Repair Way
Engine Oil Leak	Repair
Fog Light Front Left Missing	Replace
Fog Light Front Right Missing	Replace
Seat Front Right Damaged	Repair
Front Bumper Paintwork • Scratched	Repair
Grill Damaged	Repair
Bonnet Dented	Repair
Bonnet slam plate (Shock tower/ Inner tray) Residual	Repair
Traces of Repair	Repair
Front Fender Left Paintwork • Scratched	Repair
Front Fender Right Paintwork • Scratched	Repair
Rear Fender Left Paintwork • Scratched	Repair
Rear Fender Right Dented	Repair
Door Front Left Dented	Repair
Door Front Right Paintwork • Scratched	Repair
Door Rear Left Paintwork • Scratched	Repair
Door Rear Right Paintwork • Scratched	Repair
Tailgate Paintwork • Scratched	Repair
Rear bumper Damaged	Repair
Rocker Panel Right Damaged	Repair
Windscreen Chipped	Repair
Shock Absorber Mounting Rear Left Damaged	Replace
Shock Absorber Mounting Rear Right Damaged	Replace
Stabilizer Mounting Front Left Defective	Replace
