## CONDITION REPORT

Report No: 201688601

| Manufacturer | TOYOTA | Registration Number | KL86ZHGP |
| Model | COROLLA QUEST 1.6 [2016-2021] | Register Number | |

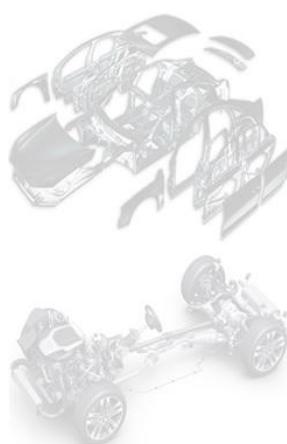
| Damage | Repair Way |
| Engine Oil Leak | Repair |
| Central Air Vent Damaged | Repair |
| Windscreen Wiper Damaged | Replace |
| Tail Light Left Damaged | Replace |
| Seat Front Right Worn | Repair |
| Front Bumper Damaged | Repair |
| Bonnet Damaged | Repair |
| Front Fender Left Damaged | Repair |
| Rear Fender Left Damaged | Repair |
| Door Front Left Damaged | Repair |
| Door Front Right Damaged | Repair |
| Door Rear Left Damaged | Repair |
| Door Rear Right Damaged | Repair |
| Boot Lid / Hatch door Damaged | Repair |
| Rear bumper Damaged | Repair |
| Windscreen Damaged | Replace |
| Brake disc 1. Axle left Worn | Replace |
| Brake disc 1. Axle right Worn | Replace |
| Parking Brake Performance Left / Right Difference out of legal range | Repair |
