## CONDITION REPORT

Report No: 2016289113

MFC Auction House  
M57 Pretoria Rd, Glenmarais, KEMPTON PARK  
Gauteng

Vehicle Type	PASSENGER VEHICLE	Registered Owner	MFC AUCTION HOUSE
Manufacturer	TOYOTA	Registration Number	JPN790MP
Model	COROLLA QUEST	Register Number	
VIN	AHTLB52E403102125	Date Of First Licensing	
Engine Number		Last COR	
Doors	4	License Expiry Date	31/05/2024
Color	SILVER	Power / Displacement	
Year Model		Paint Finish	M - METALLIC
Km Reading	286,495 KM	Fuel	PETROL
Cab / Body Type	SEDAN	Transmission	MANUAL

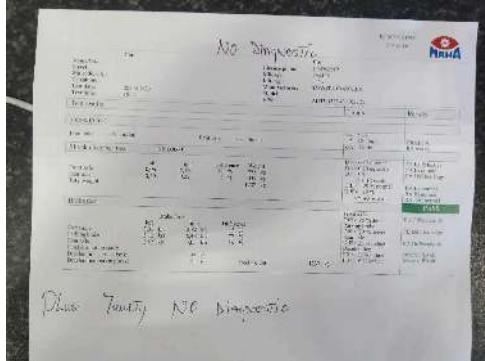
Shock and brake report

Left	Right	Axle Weight [KG]	Deceleration [m/s <sup>2</sup> ]
	Braking Force [kN]	Braking Force [kN]		
Front	3.3	2.8	-	
Rear	2.5	3.0	-	
Emergency / Parking	2.1	0.4	-

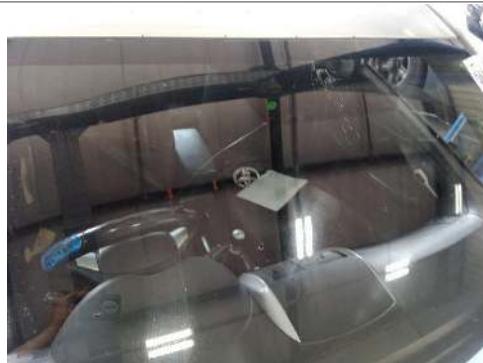
## Windscreen

Damage	Repair Way
Engine Oil Leak	Repair
Dim Light Right Defective	Replace
Bright Light Right Defective	Replace
Seat Front Right Torn / Cut	Repair
Seat Rear Torn / Cut	Replace
Side Mirror Left Damaged	Replace
Rear Lower Valance Damaged	Repair
Front Bumper Damaged	Repair
Sill Panel Right Dented	Repair
Windscreen Cracked	Replace
Parking Brake Performance Left / Right Difference out of legal range	Repair
Tie Rod End left Damaged	Replace
Tie Rod End right Damaged	Replace
Split Pin Right Missing	Replace
Shock Absorber Front Right Sweat	Replace
Stabilizer Mounting Front Left Damaged	Replace
Stabilizer Mounting Front Right Damaged	Replace
Alignment Poor Alignment	Repair
Tyre Rear Right Excessive Wear & Tear	Replace
Rim Front Left Welded	Repair
Rim Front Right Dented	Repair
Main Beam Left Damaged	Repair
Gearbox Oil Leak	Repair
CV Joint(s) Boot(s) Front Right (inner/outer) Damaged	Replace
R/R tyre is flat.	Repair.
Electronics	L/F electric mirror malfunction.

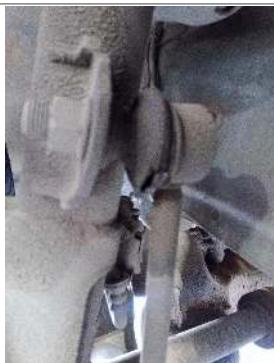
#### Stabilizer Mounting Front Right

Damage	Repair Way
Body exterior	Residual traces of poor repair work done on some b
Body exterior	Signs of welding on some body panels
Axle and suspension	Front suspension excessive noise
