## CONDITION REPORT

Report No:  
2017293105  
DATE  
02/09/2026

| Manufacturer | TOYOTA | Registration Number | CX21ZXGP |
| Model | COROLLA 1.3 PROFESSIONAL [2010-2014] | Register Number | |

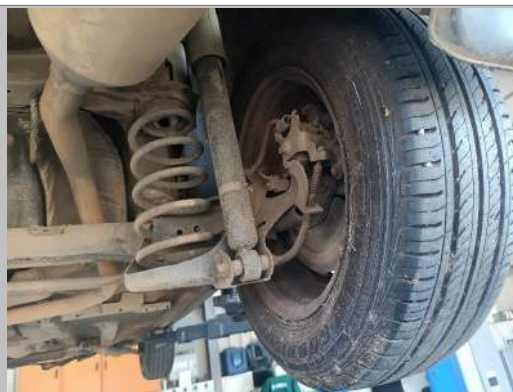
RR TYRE TREAD

| | Size | Load/Speed Index | Manufacture | Model | Type* | Production Date | Tread Depth (mm) |
|---|---|---|---|---|---|---|---|
| Rear Right | 195/65R15 | 91H | Goodride | Radial | V | 3319 | 6 mm |

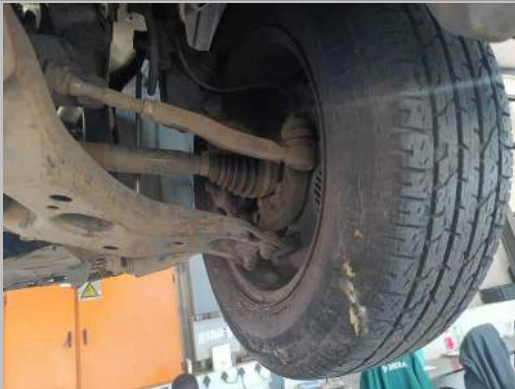
RF TYRE TREAD

| Damage | Repair Way |
|---|---|
| Rim Front Right Deformed | Repair |

| | Size | Load/Speed Index | Manufacture | Model | Type* | Production Date | Tread Depth (mm) |
|---|---|---|---|---|---|---|---|
| Front Right | 195/65R15 | 91H | Bridgestone | B390 | V | 3605 | 2 mm |
