CONDITION REPORT

Report No:  
2017306428  
DATE  
02/10/2026

| Manufacturer | TOYOTA | Registration Number | KF05YRGP |
| Model | HI-ACE 2.5 SESFIKILE 16-S DSL MINIBUS [2020-2022] | Register Number | |

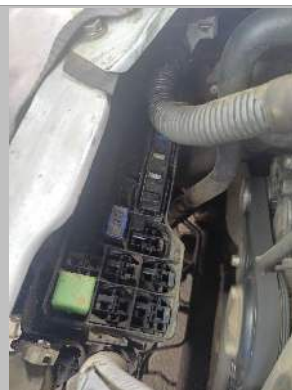
| Fuse box and fuses Damaged | Replace |
