CONDITION REPORT

Report No:  
2017165812  
DATE  
20/02/2026

MFC Auction House  
M57 Pretoria Rd, Glenmarais, KEMPTON PARK  
Gauteng

| Manufacturer | TOYOTA | Registration Number | KYH098MP |

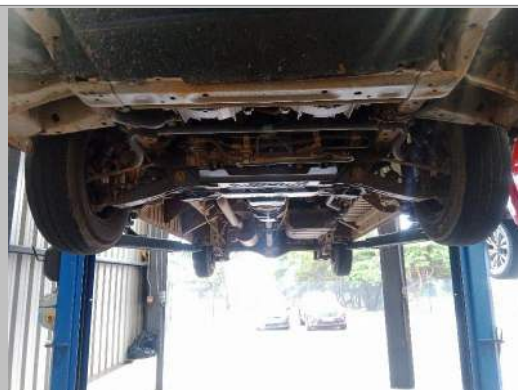
Undercarriage front.

| Damage | Repair Way |
|---|---|
| Gearbox Oil Leak | Repair |

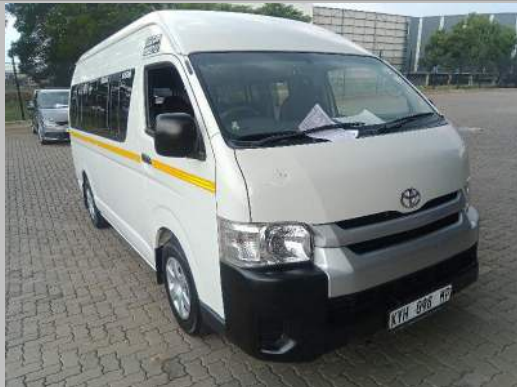
FRONT RIGHT CORNER

General Comments: ACCORDING TO THE AGE AND MILEAGE OF THE VEHICLE, NORMAL WEAR AND TEAR MARKS ARE VISIBLE ON THE INTERIOR, EXTERIOR, ELECTRICAL AND MECHANICAL PARTS. VEHICLE IS A CUT AND JOIN. Body • Exterior: Minor dents and scratches and stone chips to some body panels. Signs of repair work done to somebody panels. Repair work done to vehicle below standard. Signs of impact damage to front of vehicle.

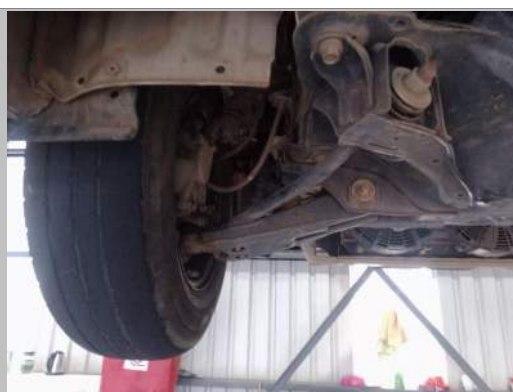
LF TYRE TREAD

| Damage | Repair Way |
|---|---|
| Tyre Front Left Worn | Replace |

| | Size | Load/Speed Index | Manufacture | Model | Type* | Production Date | Tread Depth (mm) |
|---|---|---|---|---|---|---|---|
| Front Left | 195R15C | 104S | Toyo | Radial | V | 2123 | 0 mm |

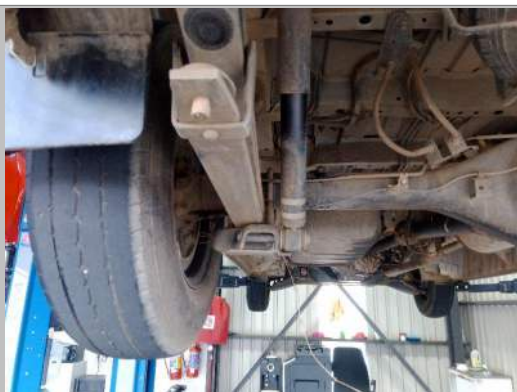
LR TYRE TREAD

| Damage | Repair Way |
|---|---|
| Tyre Rear Left Worn | Replace |

| | Size | Load/Speed Index | Manufacture | Model | Type* | Production Date | Tread Depth (mm) |
|---|---|---|---|---|---|---|---|
| Rear Left | 195R15C | 104S | Toyo | Radial | V | 2323 | 0 mm |

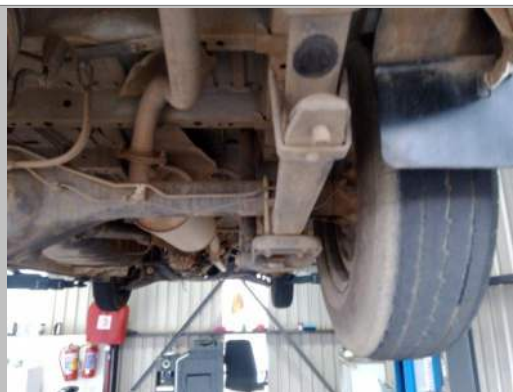
RR TYRE TREAD

| Damage | Repair Way |
|---|---|
| Tyre Rear Right Worn | Replace |

| | Size | Load/Speed Index | Manufacture | Model | Type* | Production Date | Tread Depth (mm) |
|---|---|---|---|---|---|---|---|
| Rear Right | 195R15C | 104S | Toyo | Radial | V | 2223 | 0 mm |

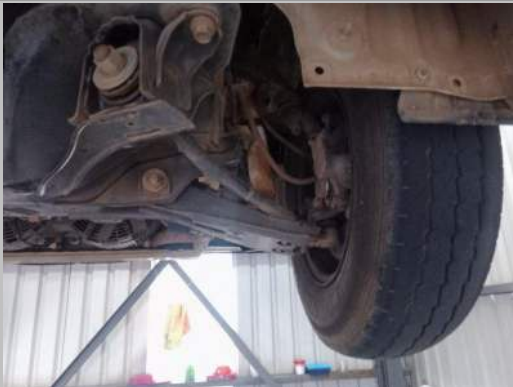
RF TYRE TREAD

| Damage | Repair Way |
|---|---|
| Tyre Front Right Worn | Replace |

| | Size | Load/Speed Index | Manufacture | Model | Type* | Production Date | Tread Depth (mm) |
|---|---|---|---|---|---|---|---|
| Front Right | 195R15C | 104R | Autogrip | Radial | V | 0325 | 0 mm |
